5. Engineering Division Management

The Drydock #1 Incident

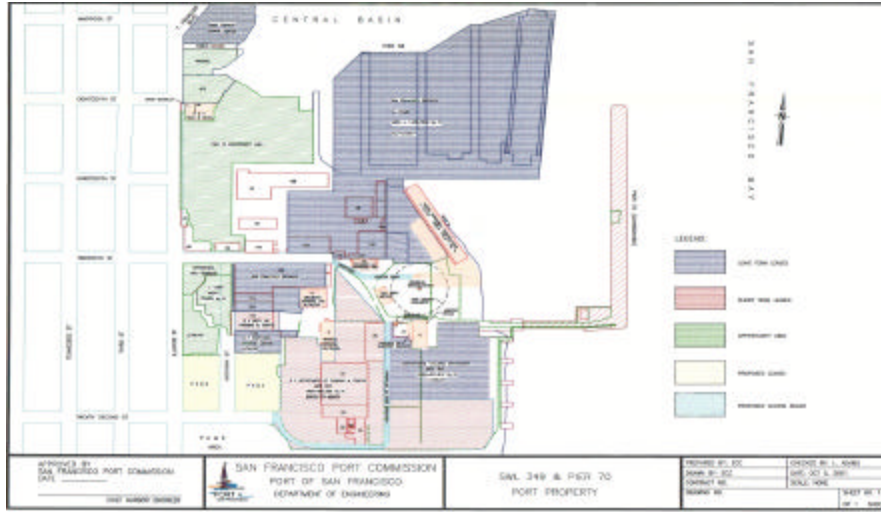
Exhibit 5.2

Pier 70, Wharf #8, is shown in Exhibit 5.2. Wharf #8 east, the location where Drydock #1 was berthed, abuts the open San Francisco Bay: there are no intervening structures to impede the path of a vessel or drydock that sets out to the Bay from Wharf #8.

Pier 70, Wharf #8, is fenced, not open to the public, dilapidated, and has holes in its deck through which a human might fall. Concerning the current condition of Wharf #8, in a March 5, 2004, memorandum to the Port’s Chief Harbor Engineer and Facilities Assessment Engineer, the Port’s structural engineer made the following statements concerning the forces imposed on Wharf #8 by Drydock #1:

The attached photographs clearly depict several failures in the wood framing and steel framing supporting the bits. This damage likely resulted from the huge forces imparted by the drydock on the bits and the inability of the dry-rotted wood framing and the corroded structural steel to adequately carry these forces.

Attached photograph no. 5 depicts a bit that has rotated approximately 70 degrees from its original position, clearly indicating failure due to a large applied lateral force. The pilebutt³ who participated in this reconnaissance indicated that this bitt was in this position *prior* to the berthing of the drydock!

Wharf #8's substructure has in general incurred severe environmentally-induced structural damage, resulting in substantially reduced lateral load-carrying capacities for its bits. The wharf has not been maintained, and the corrosive damage to structure has occurred and accumulated over decades. Wharf #8 should at this point be red-tagged until a thorough structural investigation is performed and the required repairs have been completed.

Prior to the berthing of the drydock at Wharf 8, there existed clear evidence of accumulated structural damage to the pier's substructure. The severely rotated bitt shown in attached photograph no. 5 plainly indicates an obvious structural failure, likely from a ship's or barge's applied berthing lateral force, that occurred prior to the drydock's berthing at Wharf 8. This somewhat spectacular structural bitt support failure alone provides evidence that the remainder of the bitts' support framing is suspect.
