**Sharp Park Mitigation Bank  
San Mateo County, California**

# Sharp Park Conceptual Restoration Alternatives Report

**Sharp Park Conceptual Restoration Plan**

# **JURISDICTIONAL WATERS OF THE US AND WETLAND DETERMINATION REPORT Laguna Salada Wetland Restoration and Habitat Recovery Project**

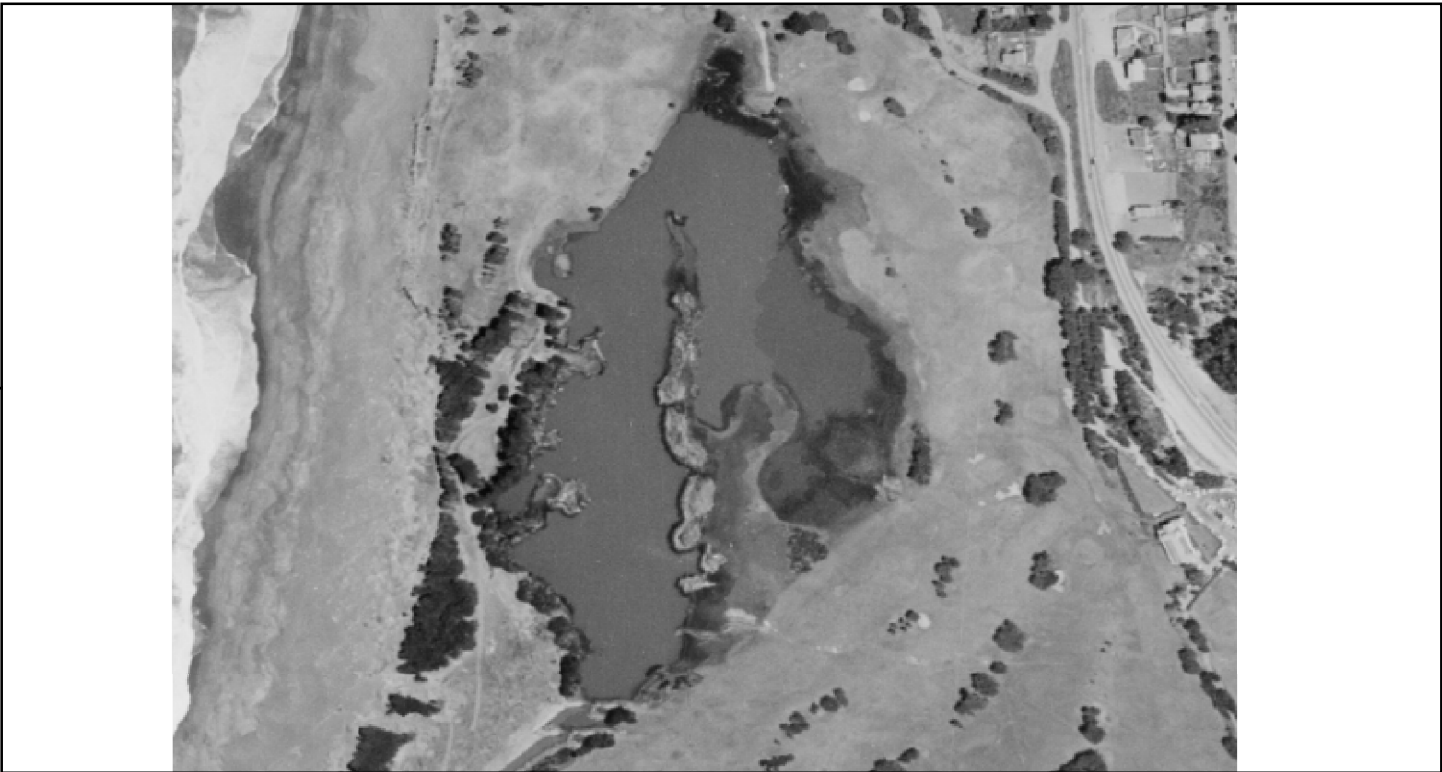
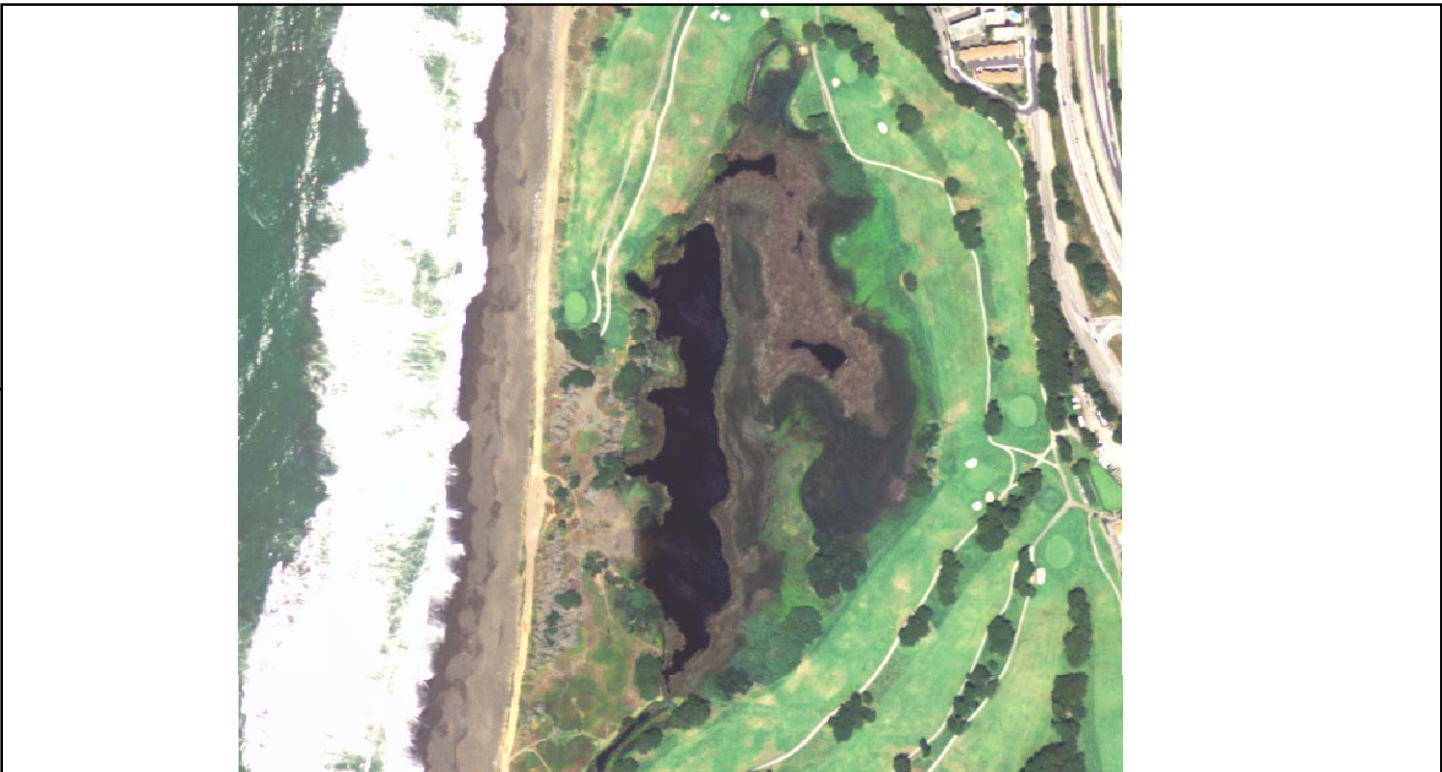
**Aerial Photos From  
1956 And 2005**

1956

2005

Ongoing sedimentation of the lagoon has increased as sediment from the watershed is no longer flushed into the ocean during tidal surges or large storms. Sediment sources include erosion of dirt roads and parking areas, as well as natural input from erosion of Sanchez Creek and lightly vegetated hillsides. This has resulted in a higher bottom elevation of the wetland complex over time, allowing shallow emergent vegetation to spread at the expense of open water. Aerial photographs of the lagoon in 1956 and 2007 show the extent to which the open water part of the lagoon has converted to vegetated wetland (Figure 3).

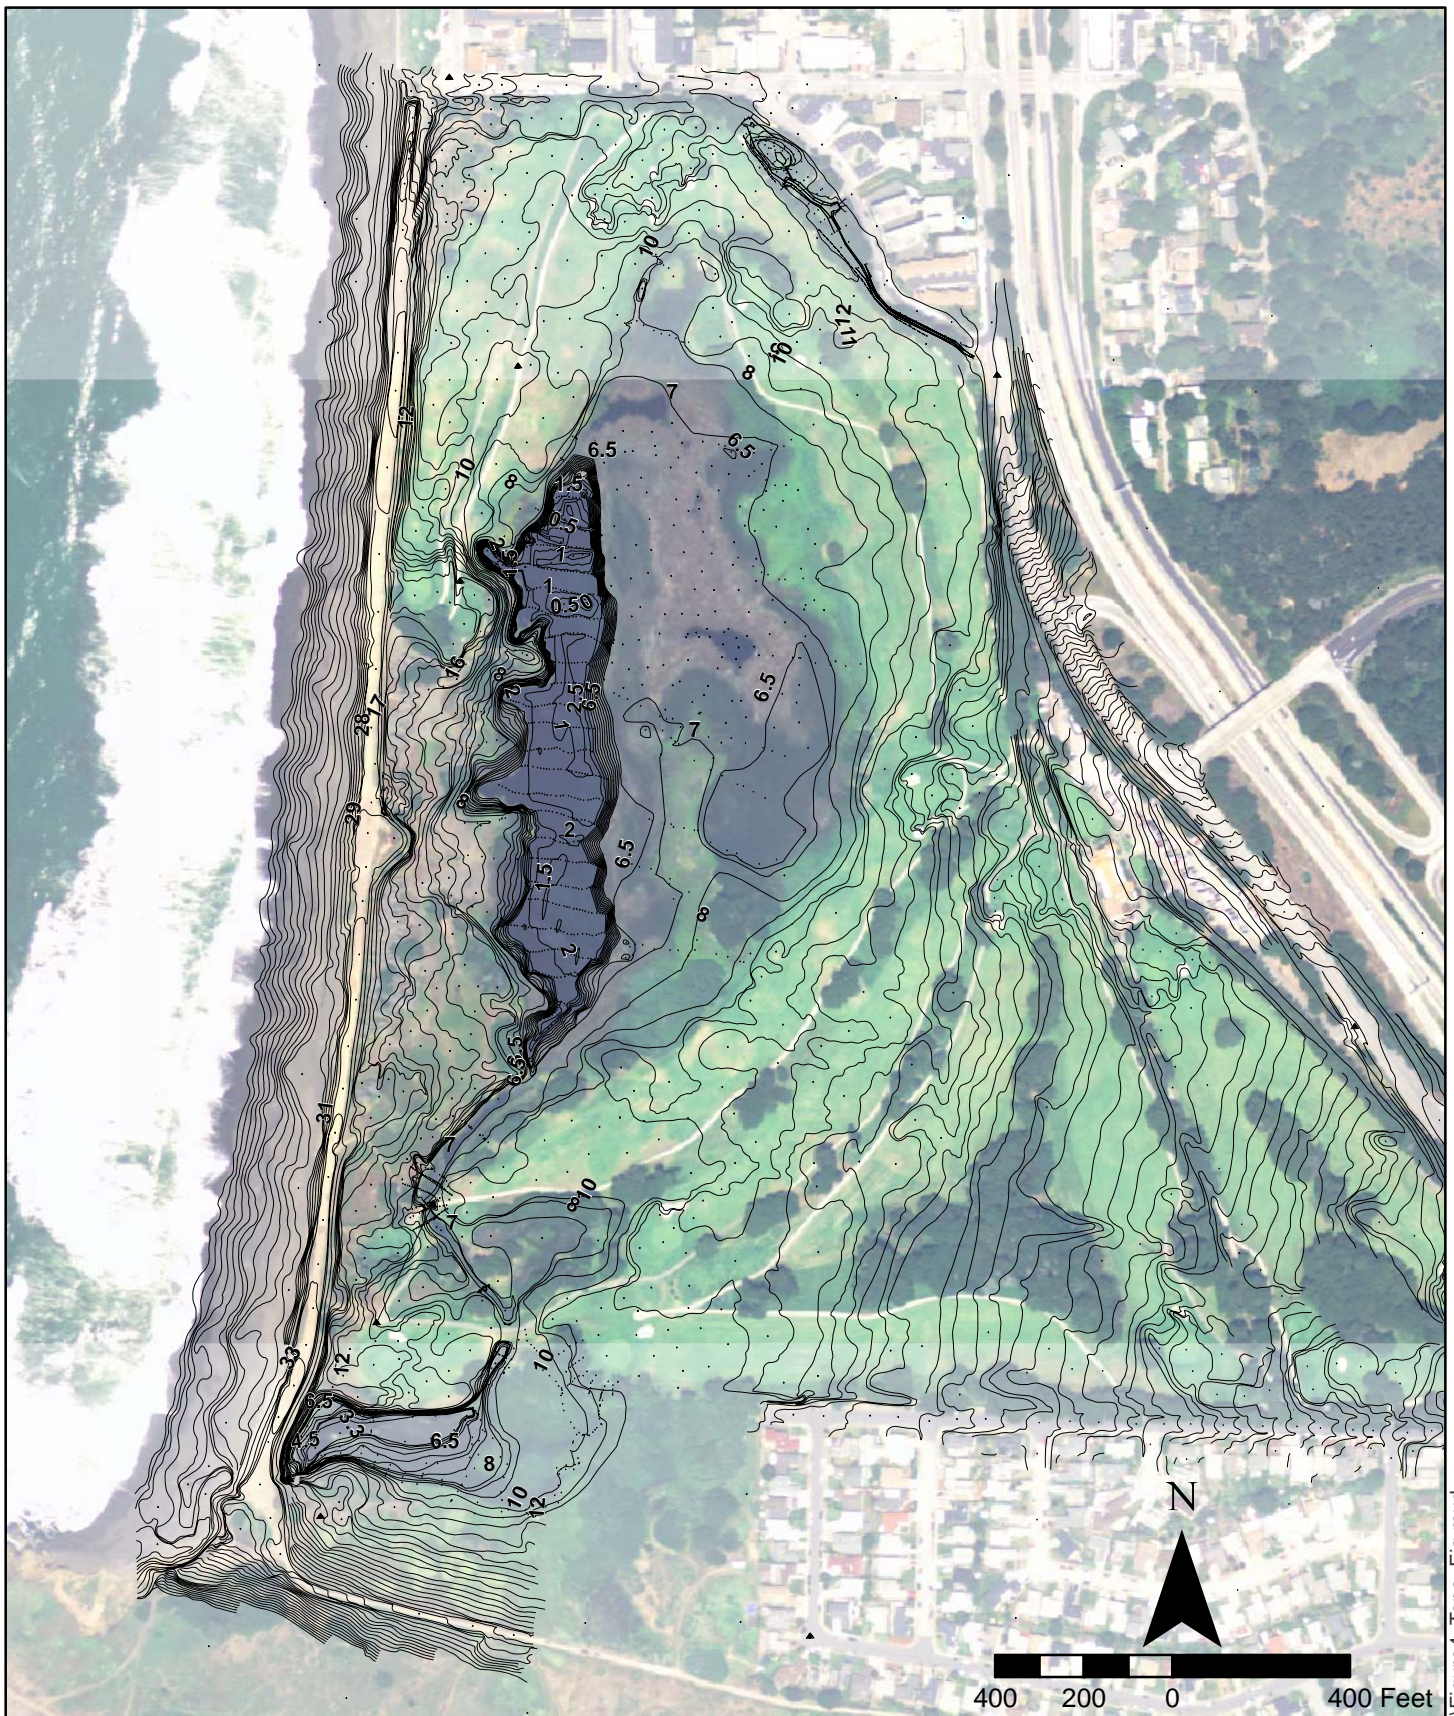
## Topography And Bathymetry

Topography displayed at 1.0' intervals  
 Bathymetry displayed at 0.5' intervals

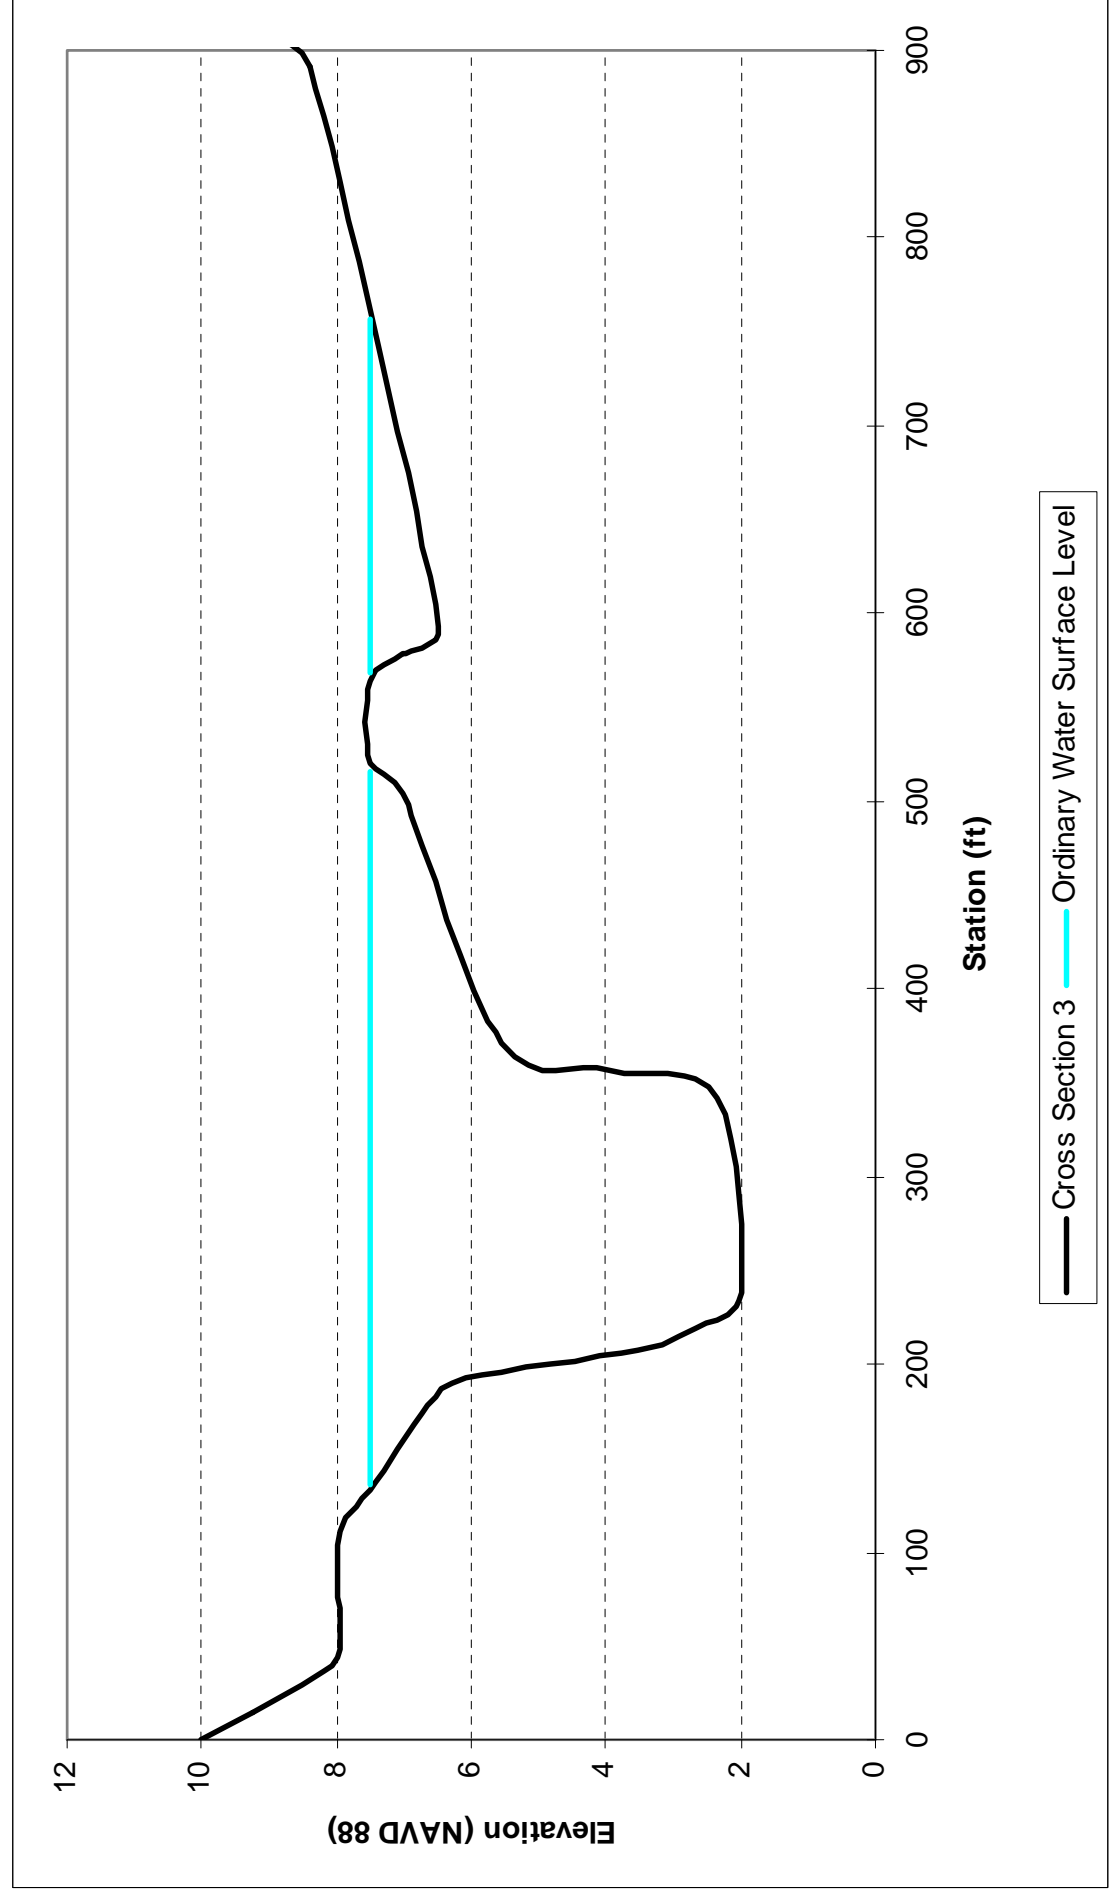
**Figure 8**

**Cross Section 3**  
(Refer to Figure 5 for cross section locations)

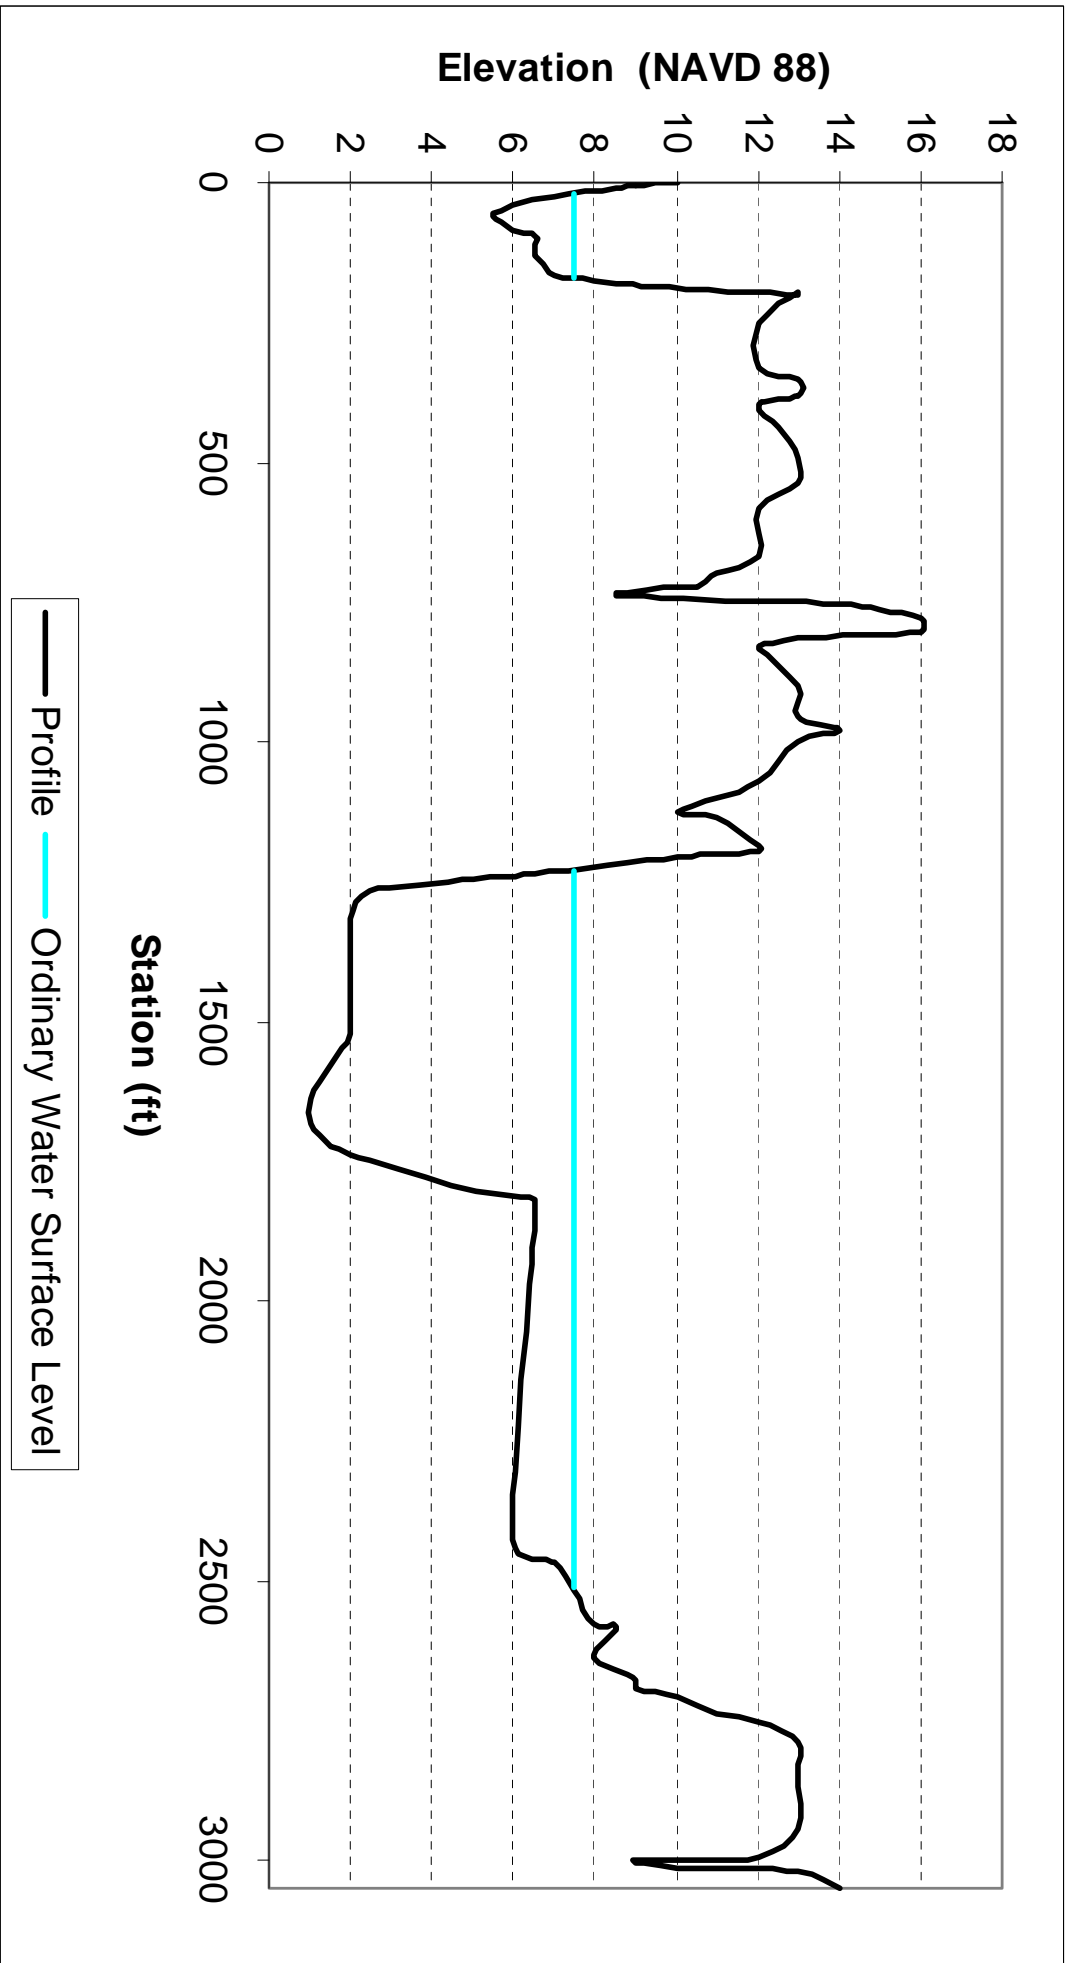
**Figure 11**

**Profile of Wetlands Complex**  
 (Refer to Figure 5 for cross section locations)

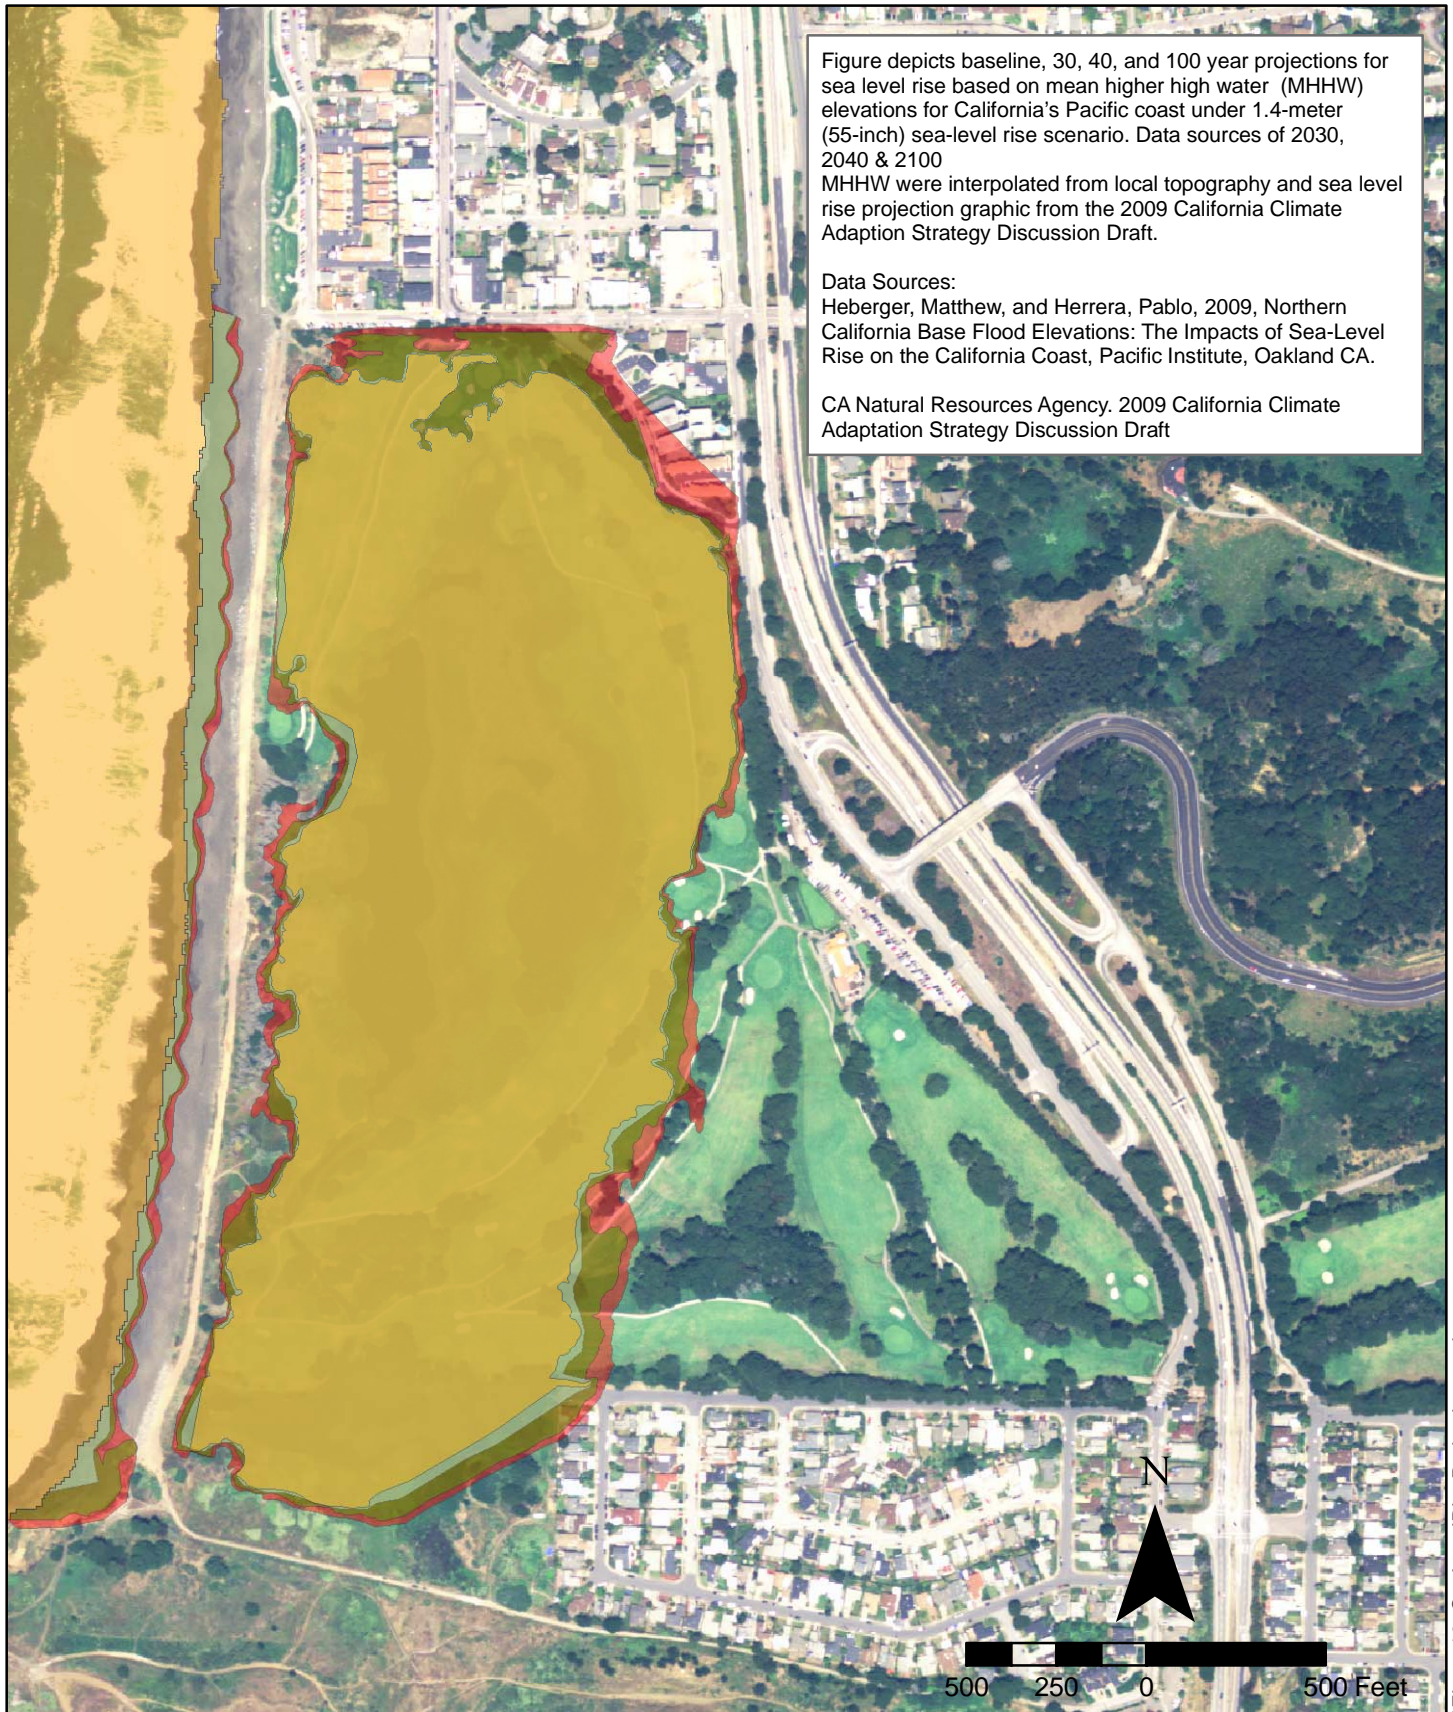
Figure depicts baseline, 30, 40, and 100 year projections for sea level rise based on mean higher high water (MHHW) elevations for California's Pacific coast under 1.4-meter (55-inch) sea-level rise scenario. Data sources of 2030, 2040 & 2100 MHHW were interpolated from local topography and sea level rise projection graphic from the 2009 California Climate Adaption Strategy Discussion Draft.

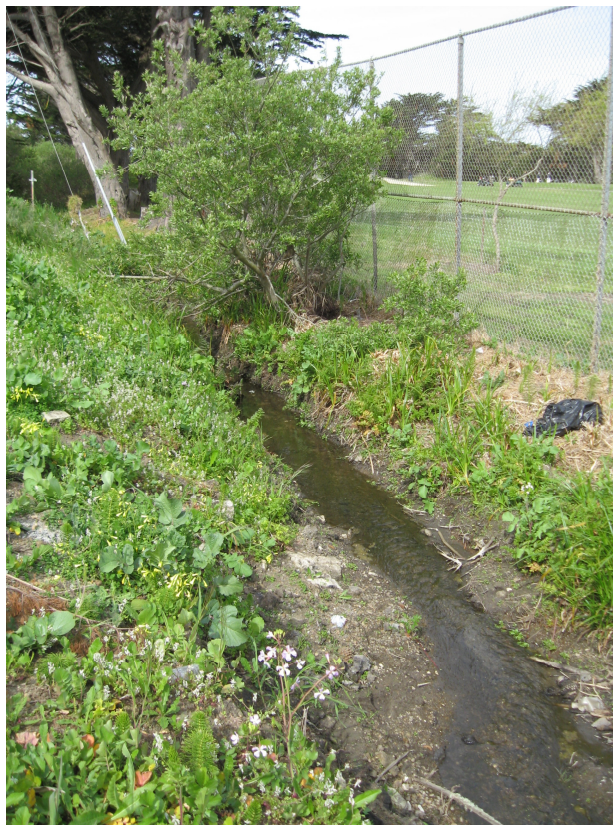
Eastern end of Sanchez Creek (February 2008)

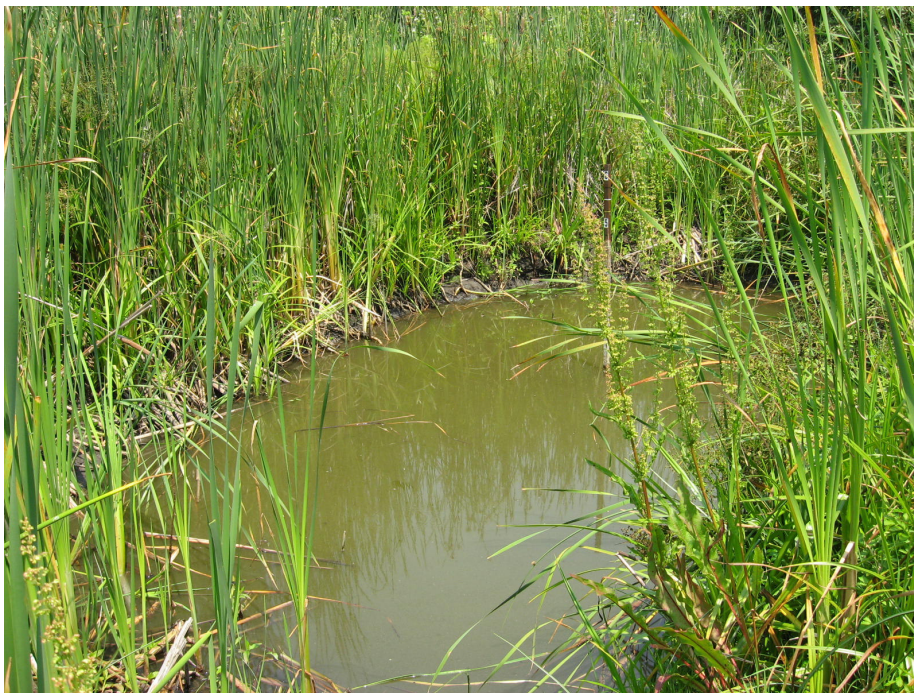
Pond created by National Park Service as California red-legged frog habitat (June 2008)

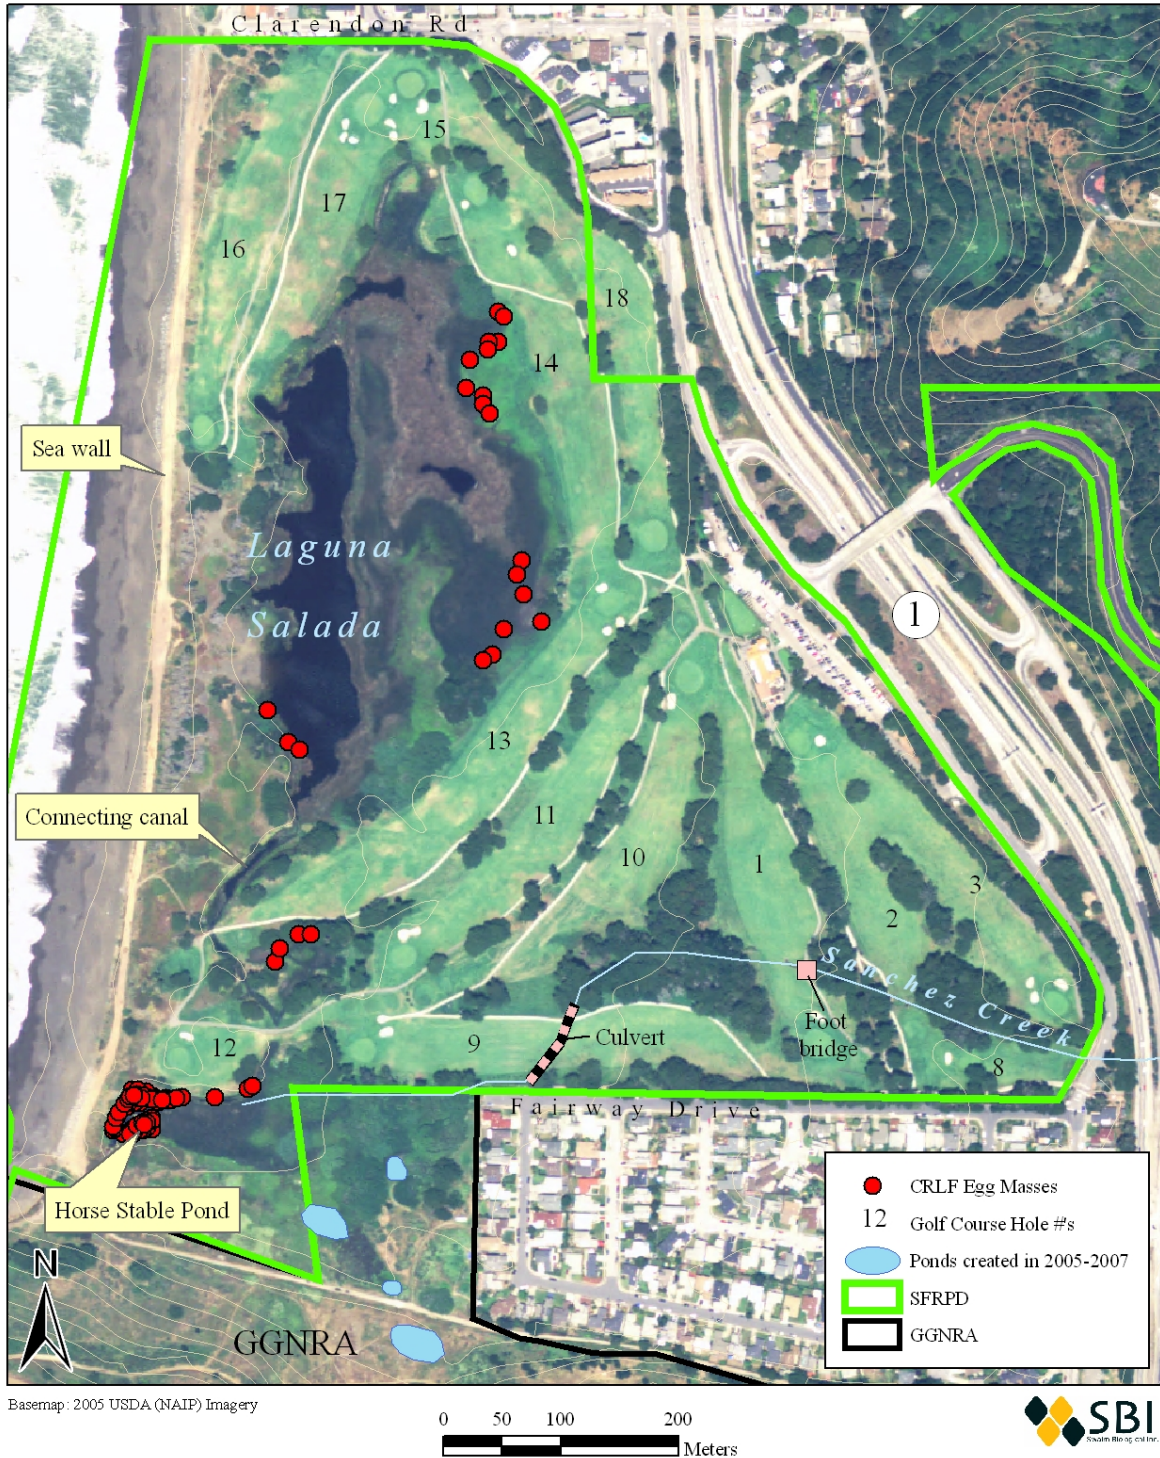
Figure 2. Distribution of California red-legged frog egg masses west of CA Hwy 1.

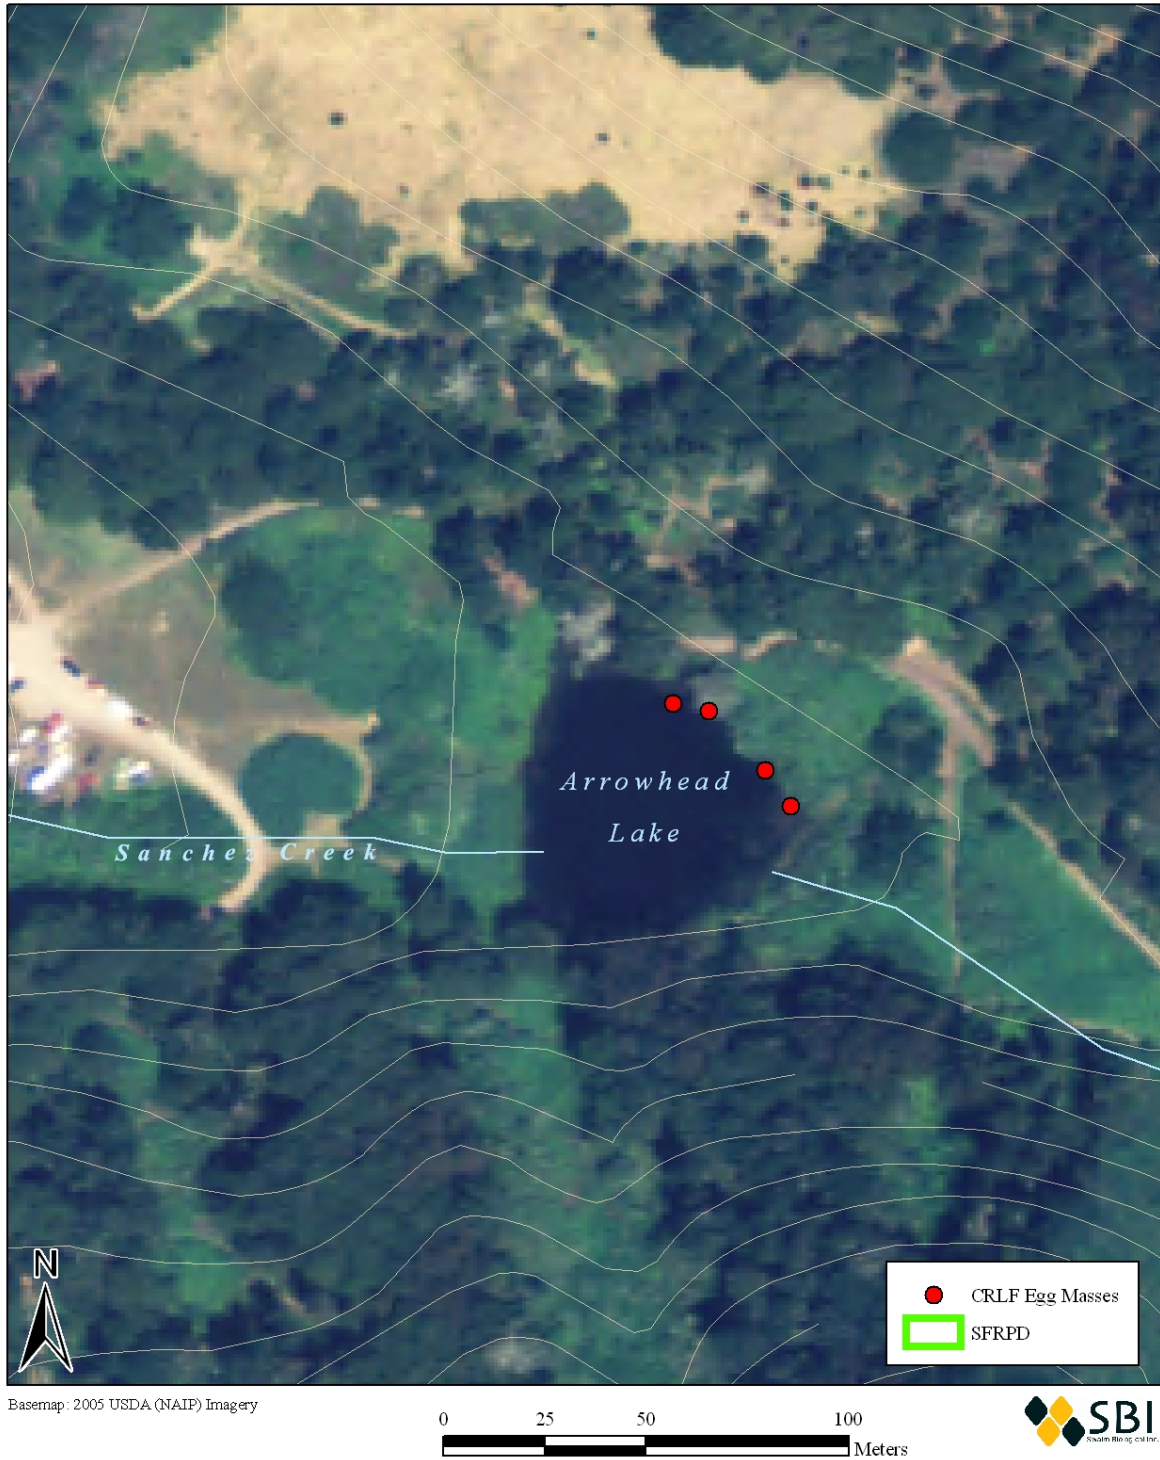
Figure 3. Distribution of California red-legged frog egg masses at Arrowhead Lake.

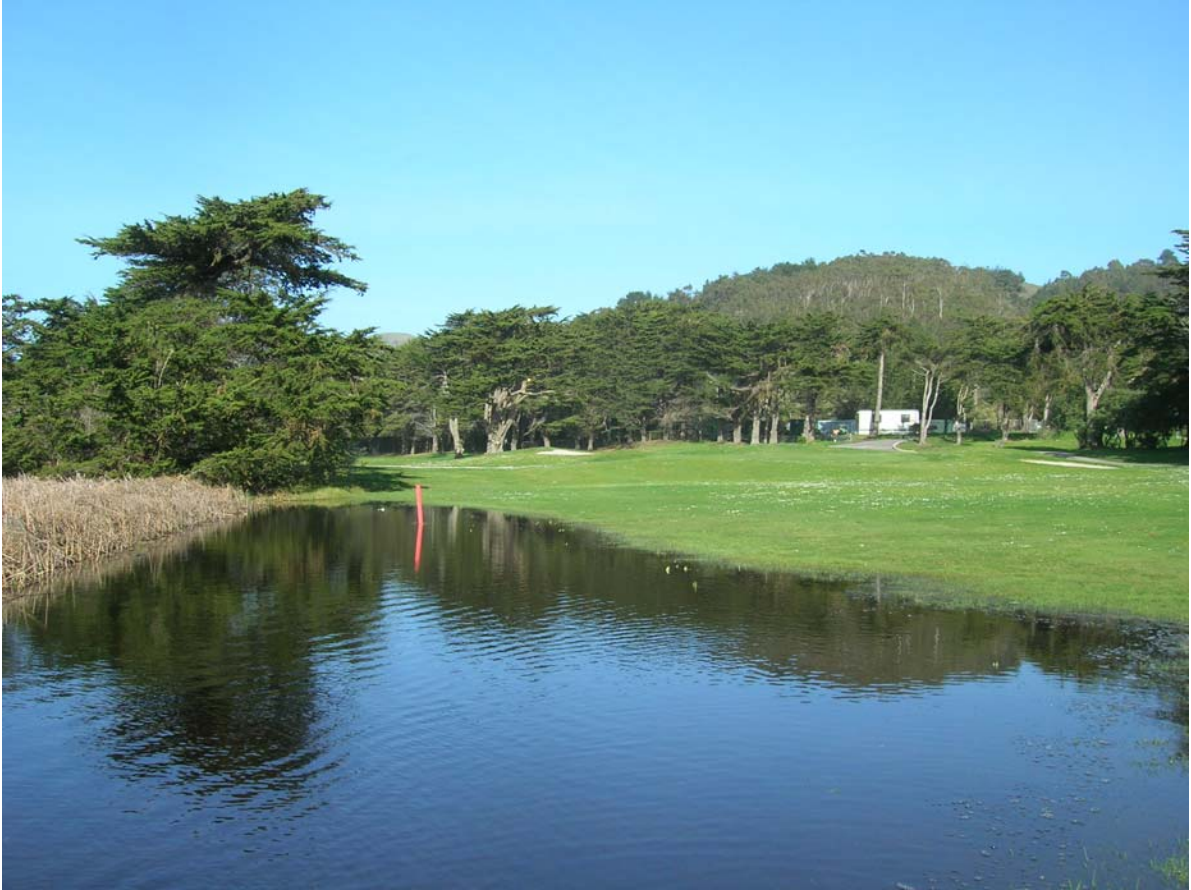
**Figure 5** Open water adjacent to dense cattails on the east side of Laguna Salada. Although California red-legged frogs bred in this habitat type in 2008, water in these areas did not persist long enough to allow tadpoles to develop.
