# **PUBLIC UTILITIES REVENUE BOND OVERSIGHT COMMITTEE CITY AND COUNTY OF SAN FRANCISCO MINUTES - DRAFT**

**October 17, 2016 - 9:00 AM**

## CALAVERAS DAM REPLACEMENT PROJECT Project No. CUW 37401

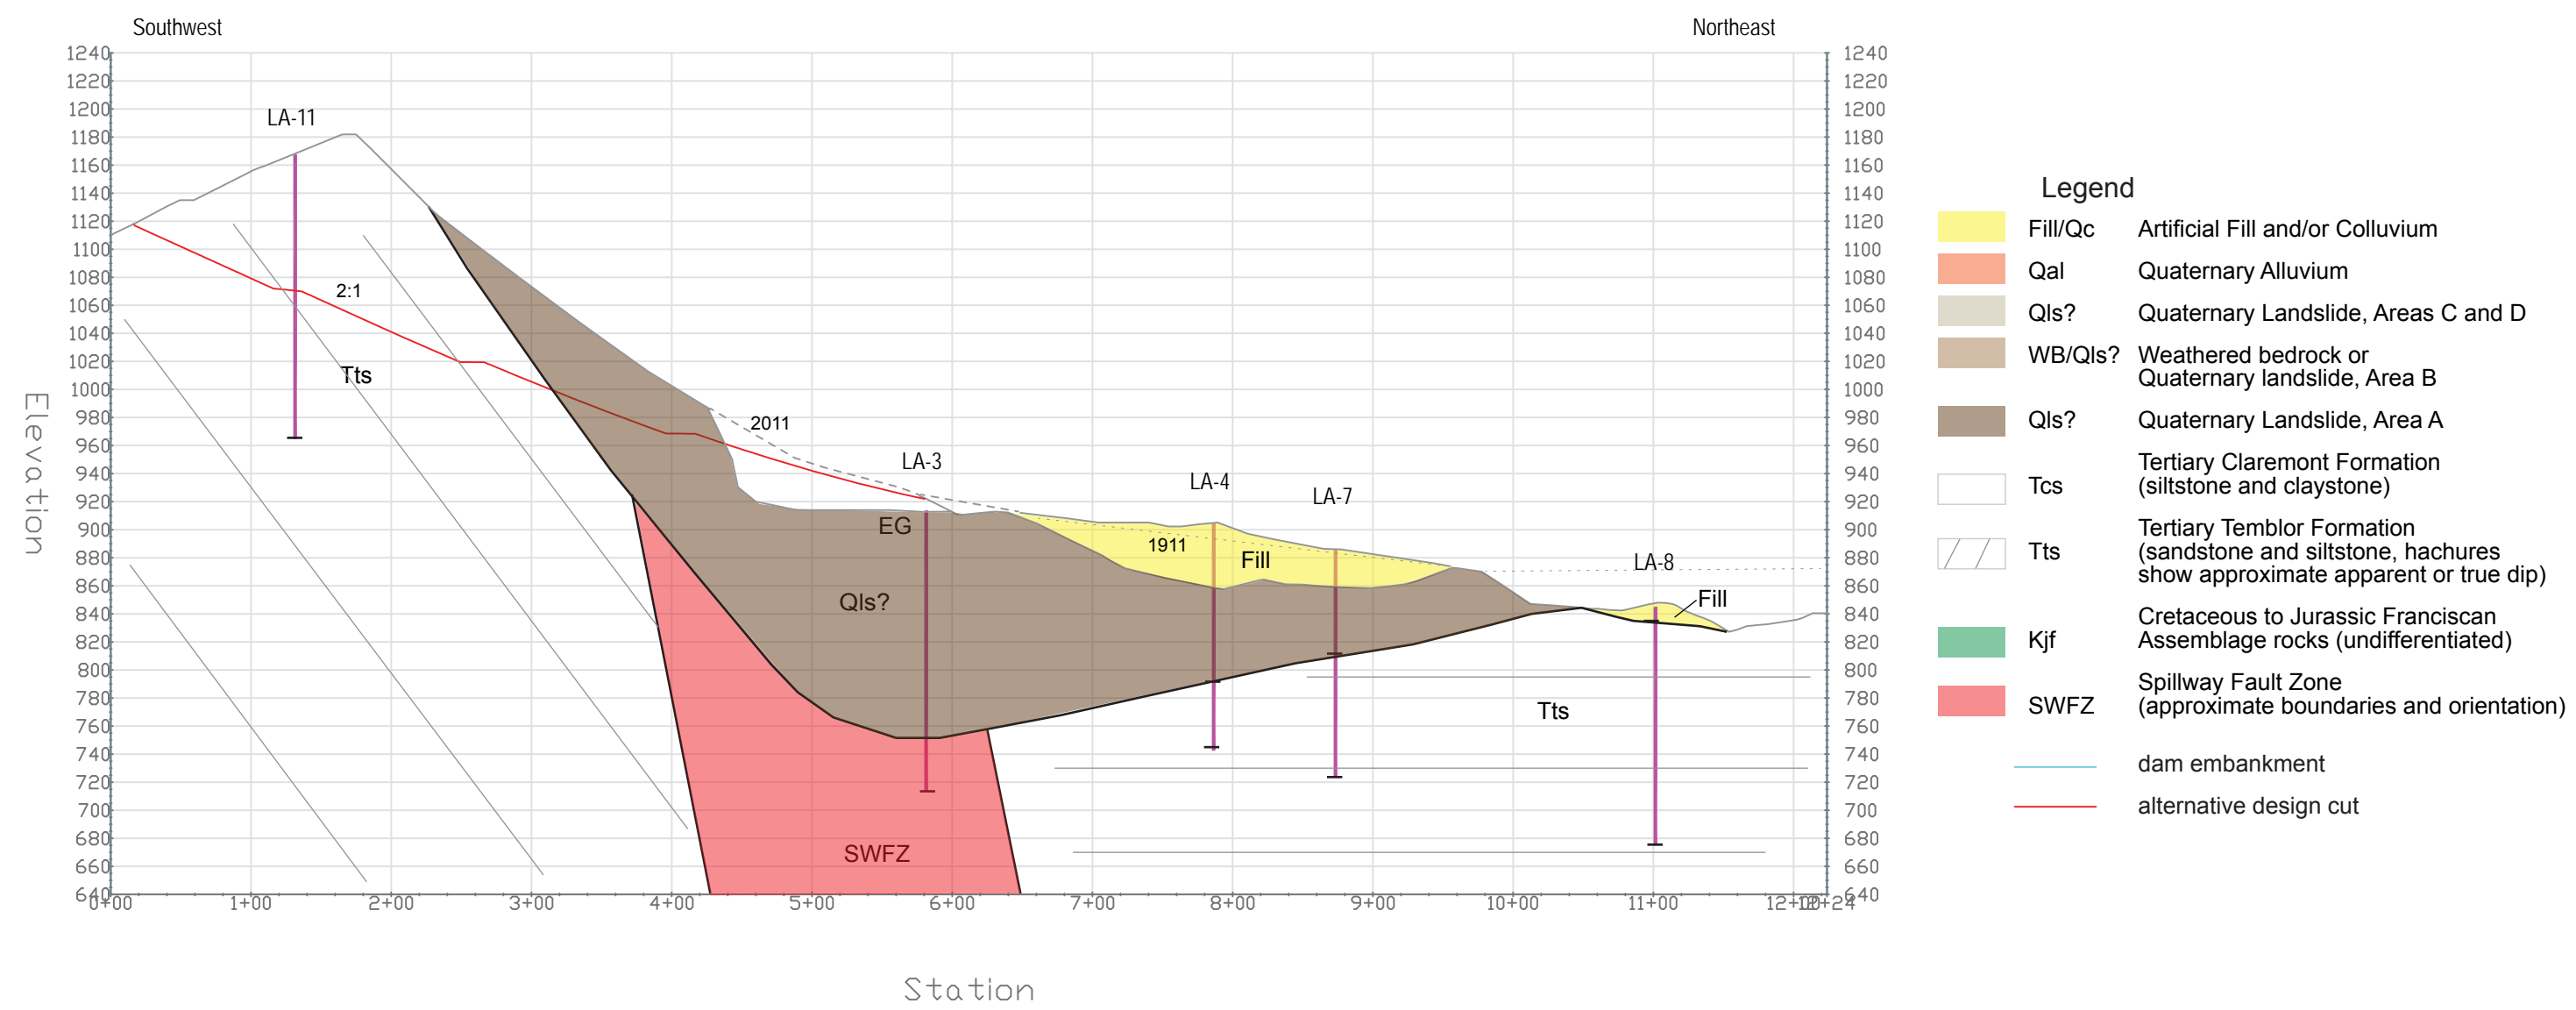
FIGURE  
2-3

GEOLOGIC CROSS SECTION  
ALONG ALIGNMENT A-10

Area A includes most of the northeastern flank of Observation Hill, which slopes steeply to the northeast and is underlain by deeply weathered bedrock and/or landslide material. Cross-section A10 (Figure 2-3) shows a representative geologic cross section perpendicular to the slope, as defined by field observations and borings LA2012-03, -04, -07, and -08 (from southwest to northeast). The upper part of the section is underlain by steeply northeast-dipping beds of the Tts sandstone, and the lower part of the section is underlain by shallowly northwest-dipping upper beds of Tts sandstone. The Spillway fault zone separates these two geologic domains; this zone is thought to be approximately 200 to 300 ft wide and composed of highly fractured and sheared rocks.

Borings LA2012-04 and LA2012-07 show similar stratigraphic relationships as those exposed in boring LA2012-03 (Figure 2-3). At depths of 36 to 108 ft, boring LA2012-04 consists of weathered and fractured, dark yellowish brown sandstone and siltstone, overlying strong, relatively unfractured gray sandstone. The basal part of the dark yellowish brown sandstone and siltstone consists of a 6-ft-thick clayey breccia from a depth of approximately 103 to 109 ft (at elevation 793 to 787 ft). The contact between the clayey breccia and the underlying hard gray sandstone is a shallowly dipping (10 degrees) planar surface. Similarly, boring LA2012-07 contains fill and weathered, fractured dark yellowish brown sandstone and siltstone material to a

depth of approximately 81 ft (elevation 808 ft) This material is associated with a smooth, basal surface that dips approximately 5 degrees (in an unknown direction) and lacks remolded clay gouge. Below this plane is light bluish gray sandstone that has substantially higher RQD and relatively few fractures. In these three borings (LA2012-03, -04 and -07, Appendix A), the contact between highly weathered, fractured material and fresh to slightly weathered gray sandstone is associated with a basal intensely fractured clayey breccia and an abrupt, shallow dipping striated plane. The overall geometry of the contact based on the three borings is shown on Figure 2-3.

Figure 2-3 also shows the generalized stratigraphic relationships exposed in boring LA2012-08. This boring shows the presence of a thin artificial fill (either from recent activities or original construction in 1911-1918), overlying strong, gray Tts sandstone with few fractures. This boring did not contain a thick section of weathered, dark yellowish brown sandstone material as in the borings to the west. The presence of strong gray Tts sandstone throughout this entire boring provides data that defines the northeastern boundary of the landslide material (unit Qls?, Figure 2-3).

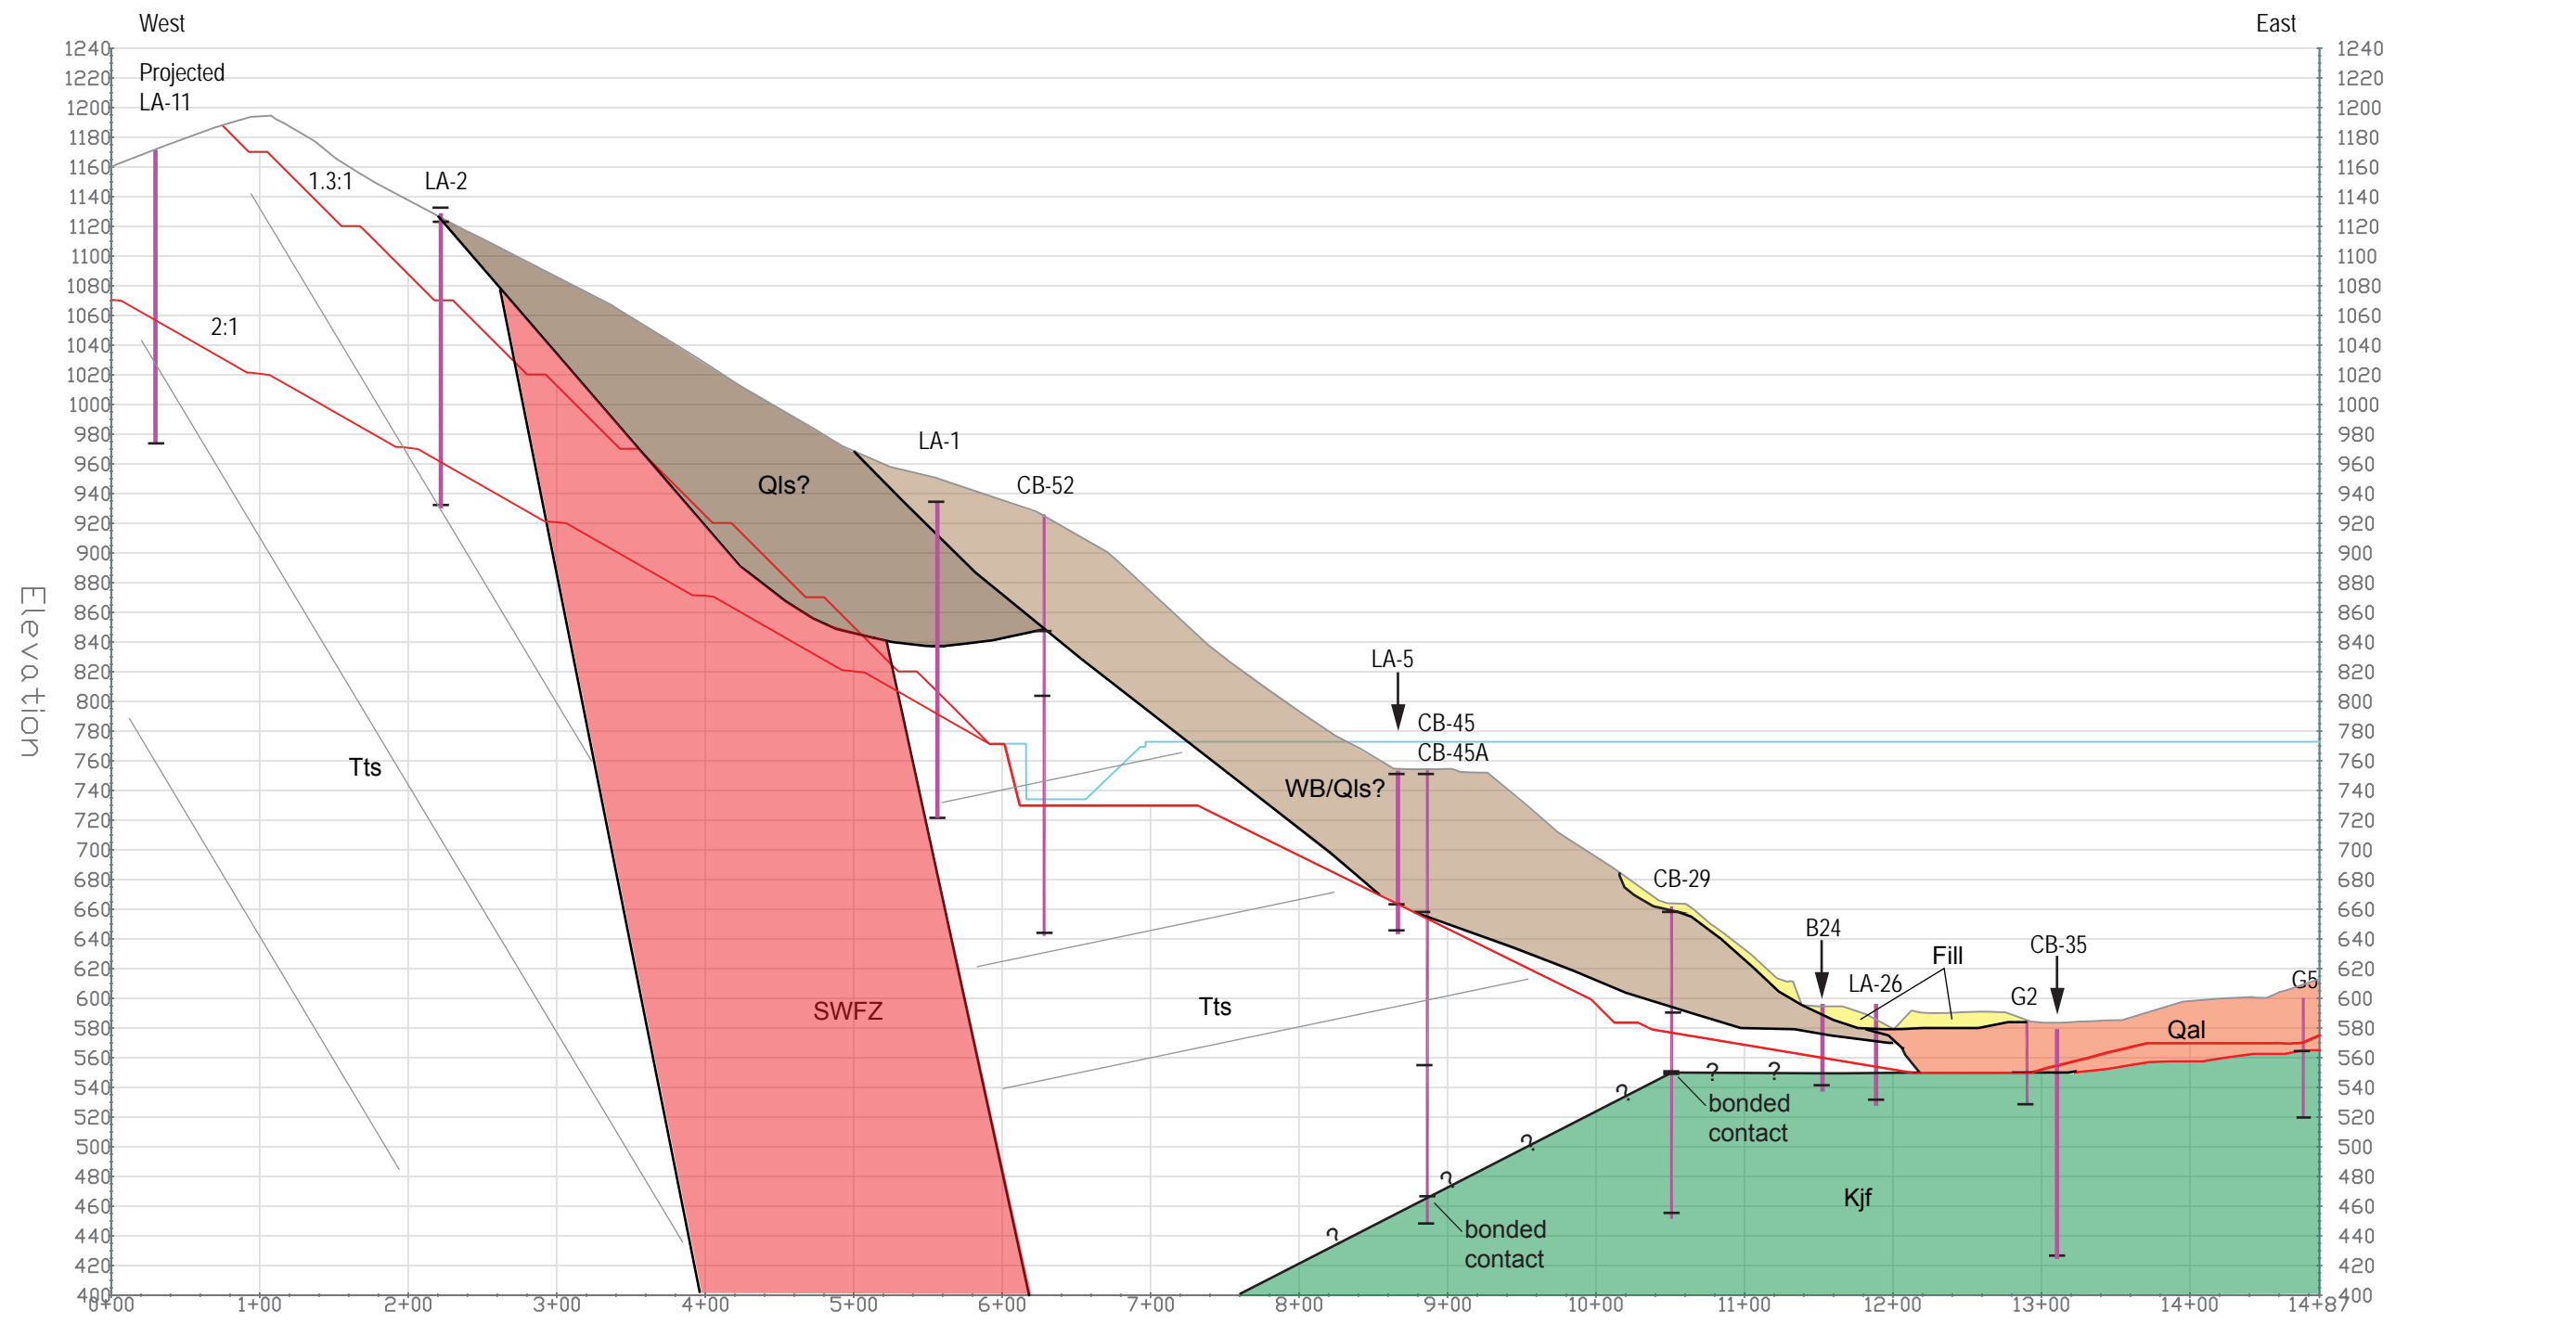
Project No. 26818183	<b>GEOLOGIC CROSS SECTION ALONG ALIGNMENT A-11</b>	<b>FIGURE 2-4</b>
	<b>SFPUC CALAVERAS DAM REPLACEMENT PROJECT</b>

Figure 2-4 shows a geologic cross section along the dam axis that traverses the southeastern part of Area A. Materials exposed in boring LA2012-01 have similar stratigraphic relationships as LA2012-03, -04 and -07. As illustrated on Figure 2-4, boring LA2012-01 exposed weathered and fractured, dark yellowish brown sandstone, which directly overlies strong, relatively unfractured gray sandstone at a depth of about 95 ft (elevation 836 ft). This contact is associated with an abrupt downward decrease in RQD, which is at the base of a breccia zone of sandstone fragments between about 80.5 and 89.3 ft depth. As illustrated on Figure 2-4, these relationships are consistent with the geometry of the stratigraphic relationships shown on Figure 2-3 in the central part of Area A.

As summarized on Figure 2-4, material characteristics exposed in borings CB-45/45A, CB-52, CB-29 are similar to those provided in the core from boring LA2012-05 and the exposure provided by bucket auger LA2012-05BA. A mixed/breccia zone of sandstone fragments, clay and silt was observed in CB-45 at a depth of 92.4 to 94.4 ft, overlying a 2-ft-thick zone of fractured yellowish brown sandstone (and a zone of no recovery) directly above hard gray sandstone. Similar breccia zones were not observed in borings CB-52 and CB-29 directly above the hard gray sandstone. Dark yellowish brown, weathered material is present to depths 96 ft (elevation 659 ft) in boring CB-45A, of 79 ft (elevation 874 ft) in boring CB-52, and 75 ft (elevation 587 ft) in boring CB-29 (Appendix A). In all three of these borings this fractured material overlies hard gray sandstone along a sharp, non-gradational contact. The eastward-dipping geometry of this contact among all these borings (as shown on Figure 2-4) is consistent with the shallow east-dipping contact exposed in bucket auger LA2012-5BA.

transported landslide material in Area A (Figure 2-4), at least some of the surficial deposits in Area B are likely to be landslide material.

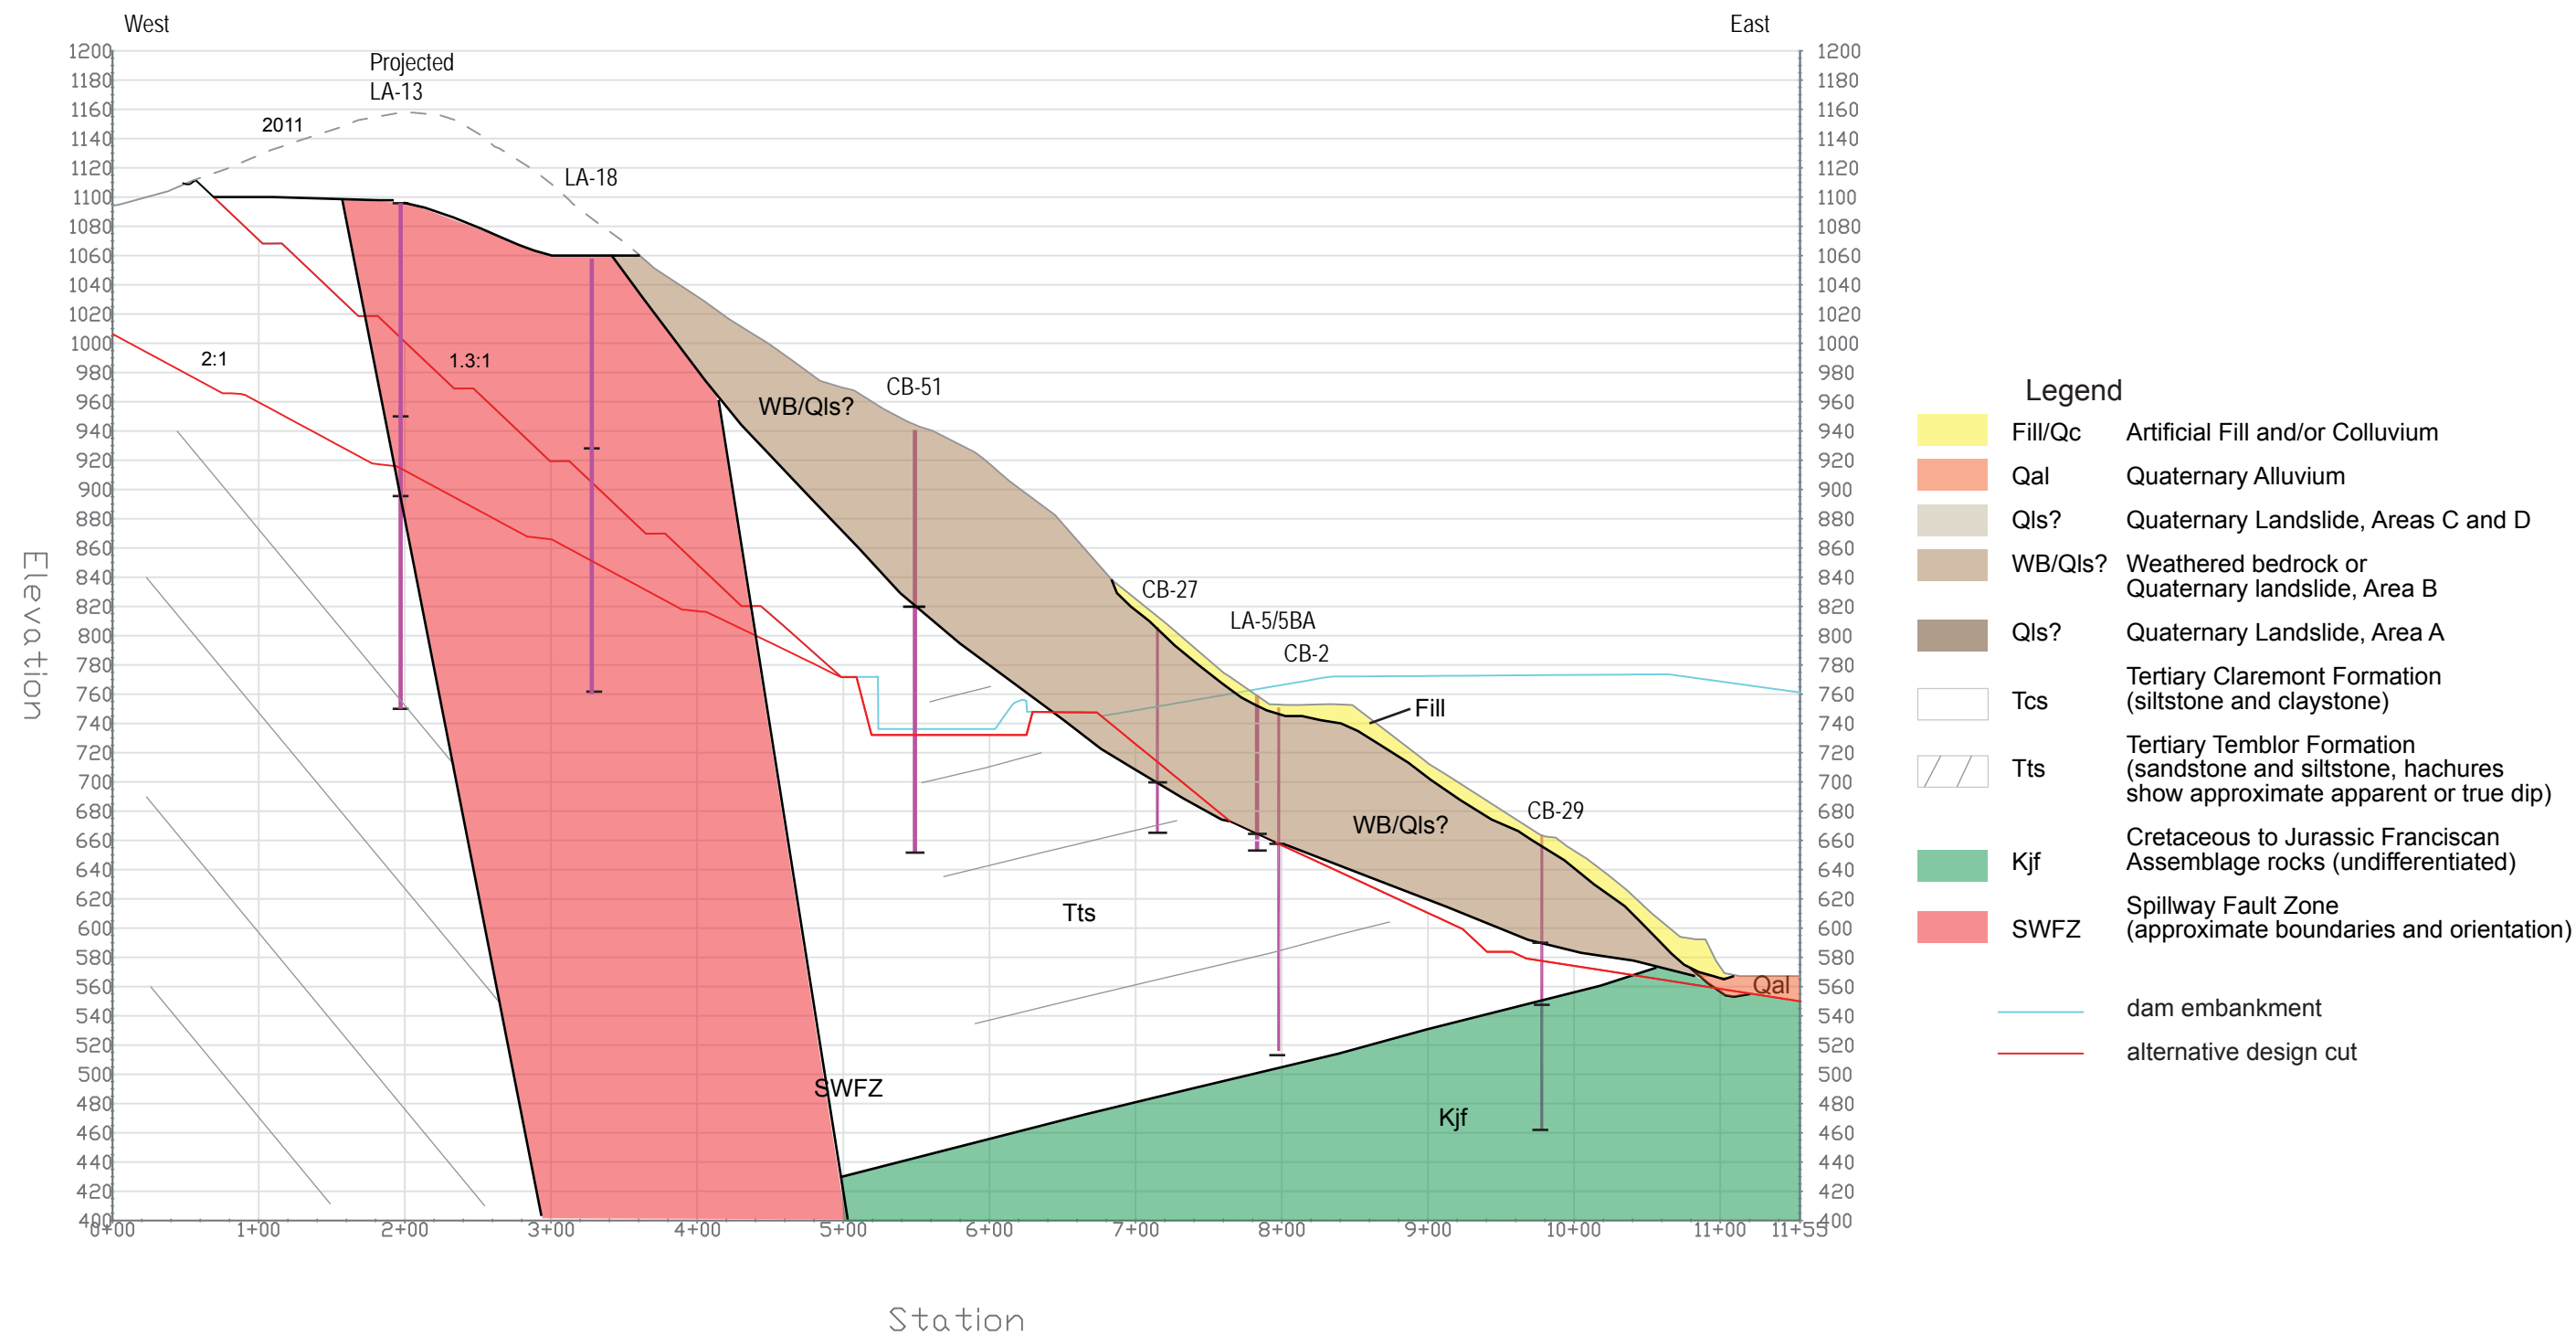
FIGURE  
2-5

GEOLOGIC CROSS SECTION  
ALONG ALIGNMENT A-12

Area B extends south of the design dam axis, and contains material that is similar to the weathered material shown by borings along the dam axis (Figure 2-4), as illustrated on geologic cross section A12 (Figure 2-5). This section crosses the dam axis near boring CB-29 (Figure 2-2). Borings CB-51, CB-27, and CB-2 exposed materials at shallow depths that are similar to the weathered, fractured dark yellowish brown materials along the dam axis. The contact between these materials and underlying hard gray sandstone is about 100 ft deep and was interpreted as the base of the weathering zone by URS (2008a). Figure 2-5 shows this material as unit “WB/Qls?” to reflect the interpretation that the material could be weathered bedrock or transported material. Additional information along this geologic cross section is provided by recent borings LA2012-13 and -18, both of which exposed steeply dipping shears and faults within intervals of brown and gray Tts sandstone. In boring LA2012-13, sheared zones at depths of about 145 ft and 175 ft have steep (50 to 70 degrees) dips and are as much as 2 ft wide in true thickness. Abundant fractures sets that have comparable dips are present above and below these prominent shears, within alternating intervals of brown and gray sandstone, suggesting that the shears are western splays of the Spillway fault zone (Figure 2-5). In boring LA2012-18, material above a depth of 114 ft (elevation 934 ft) is highly fractured and sheared, has a low RQD, and contains intervals of both dark yellowish brown and light gray sandstone. This material is interpreted to be part of the Spillway fault zone.

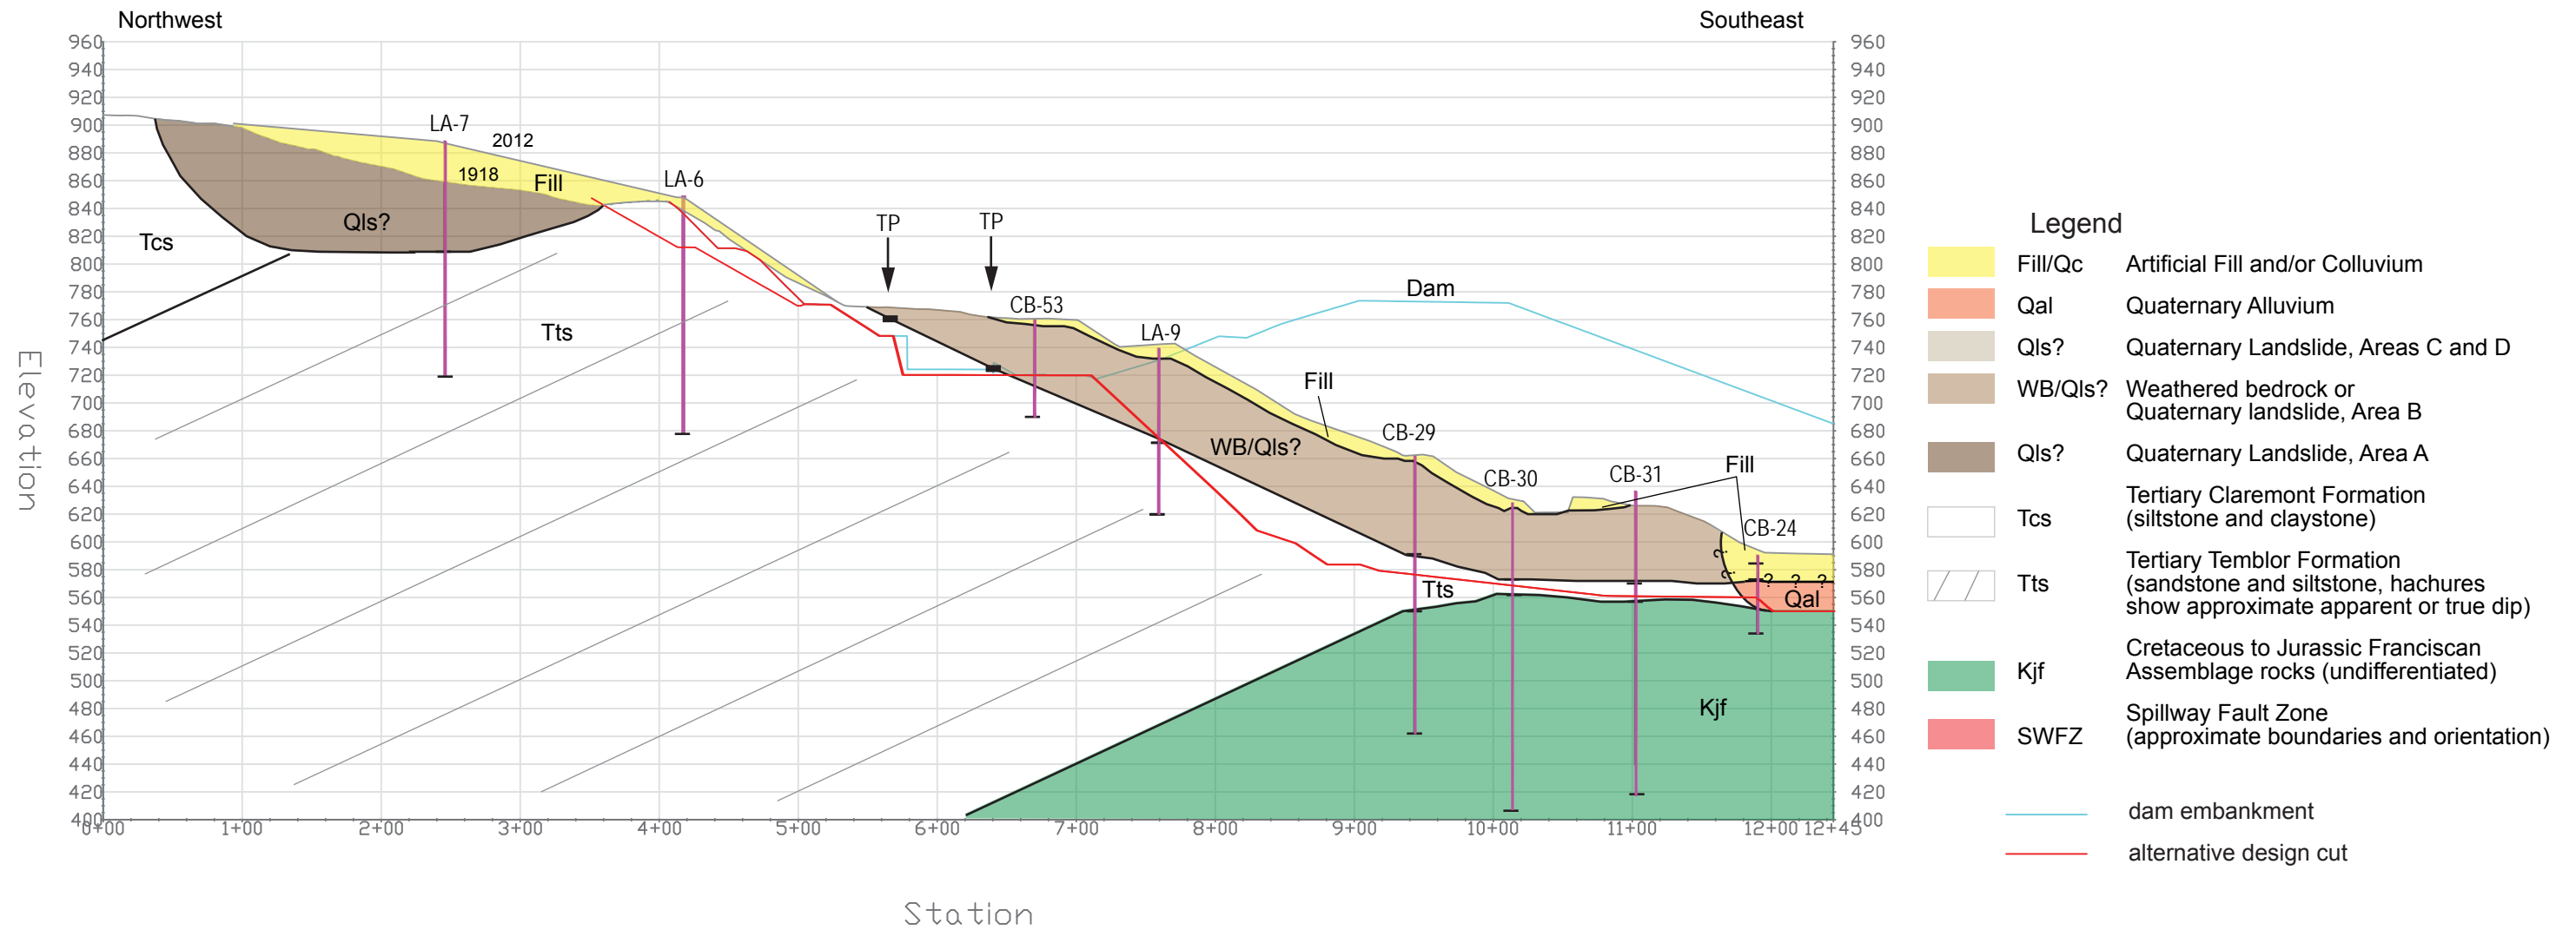
FIGURE  
2-6

GEOLOGIC CROSS SECTION  
ALONG ALIGNMENT A-8

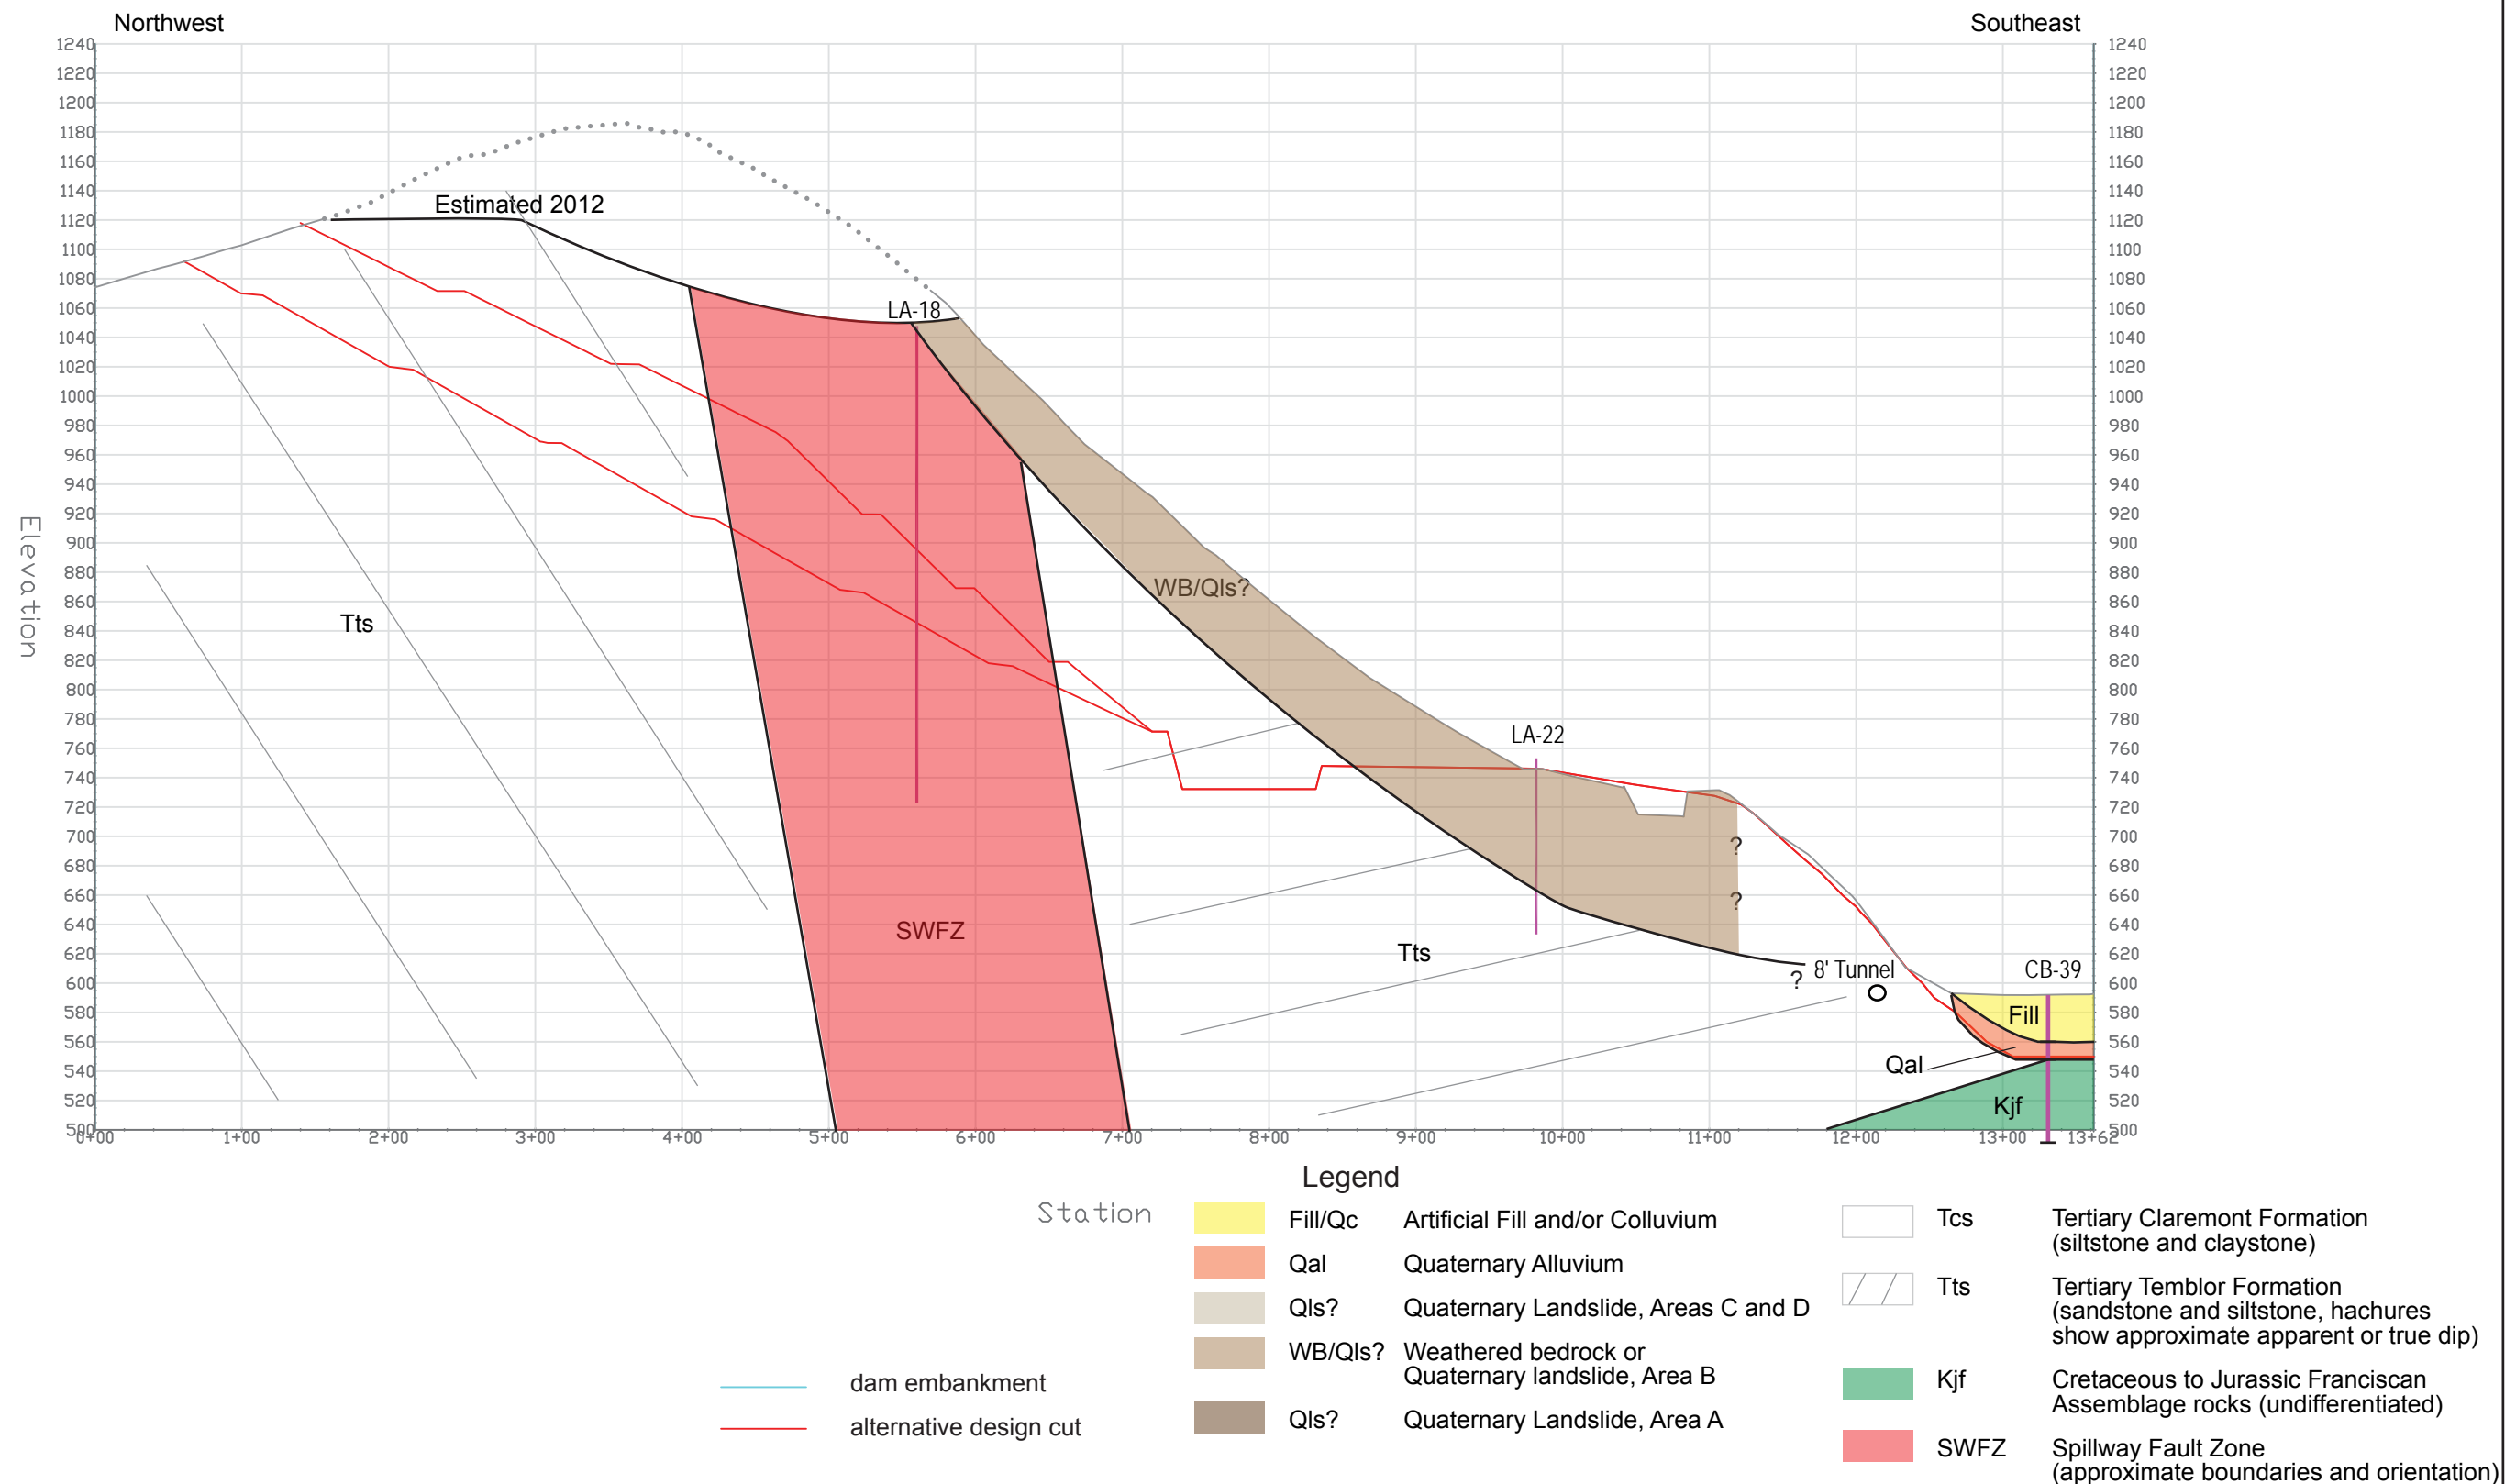
FIGURE  
2-7

GEOLOGIC CROSS SECTION  
ALONG ALIGNMENT A-14

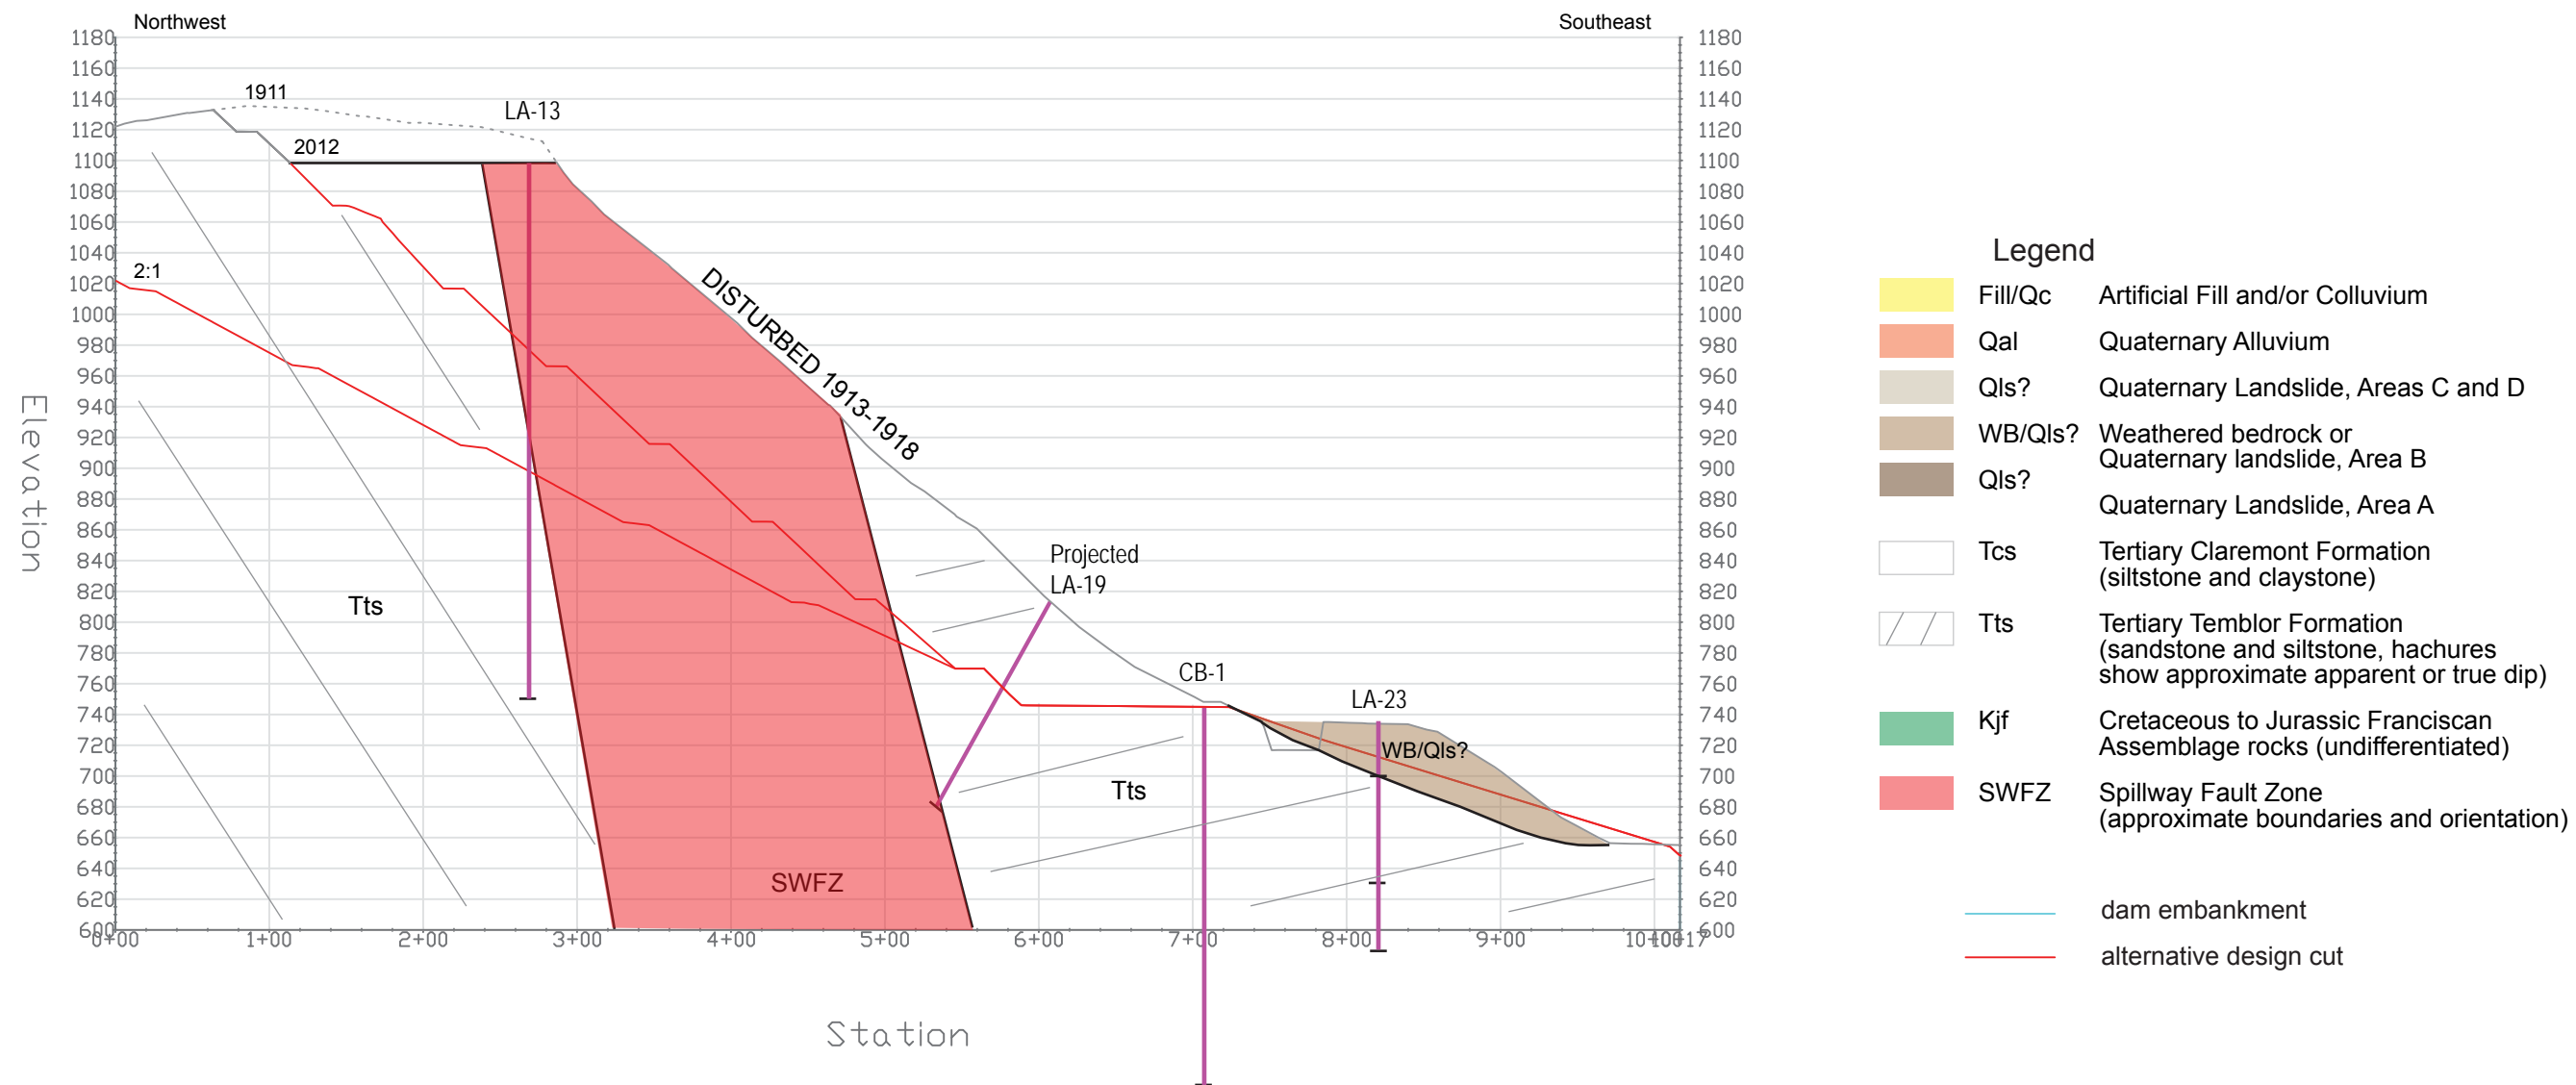
FIGURE  
2-8

GEOLOGIC CROSS SECTION  
ALONG ALIGNMENT A-13

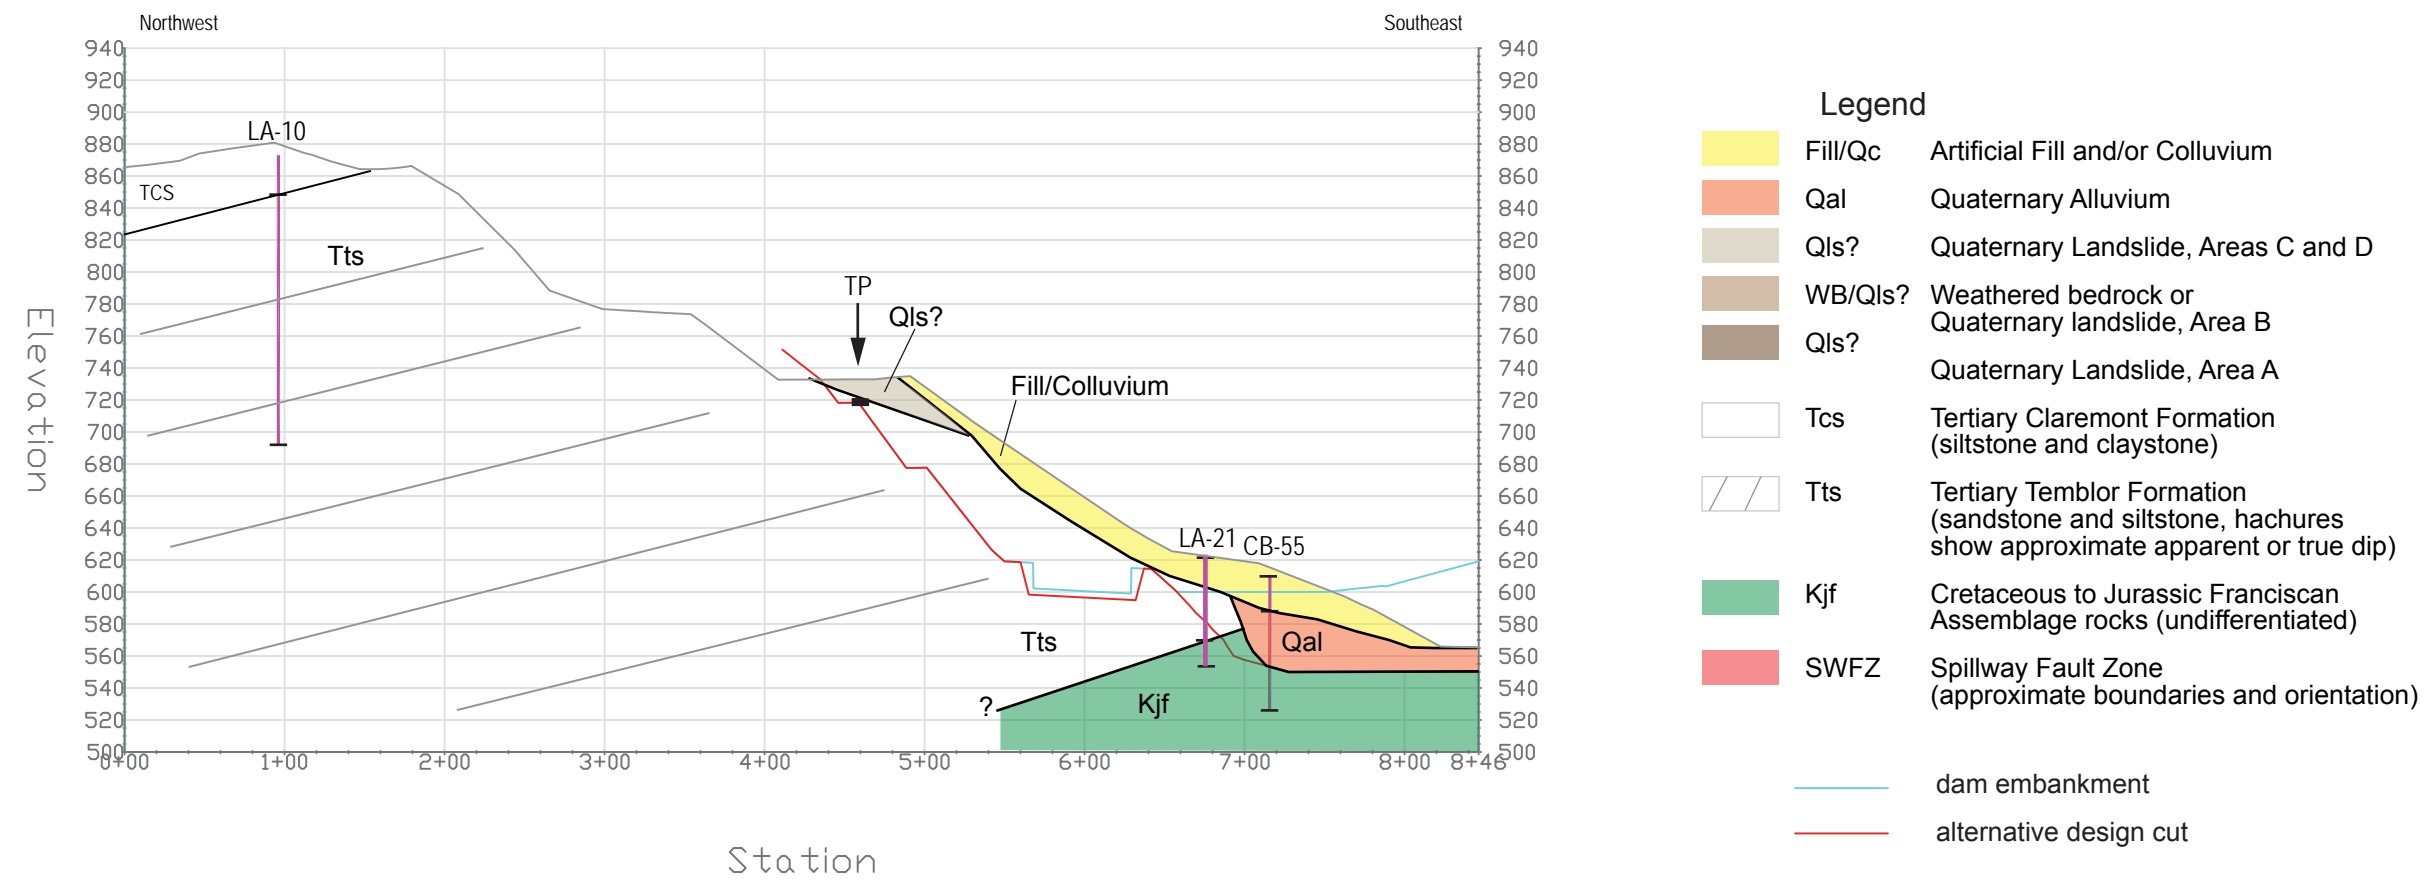
FIGURE  
2-10

GEOLOGIC CROSS SECTION  
ALONG ALIGNMENT A-6
