# **PUBLIC UTILITIES REVENUE BOND OVERSIGHT COMMITTEE CITY AND COUNTY OF SAN FRANCISCO MINUTES - DRAFT**

**October 17, 2016 - 9:00 AM**

## CALAVERAS DAM REPLACEMENT PROJECT Project No. CUW 37401

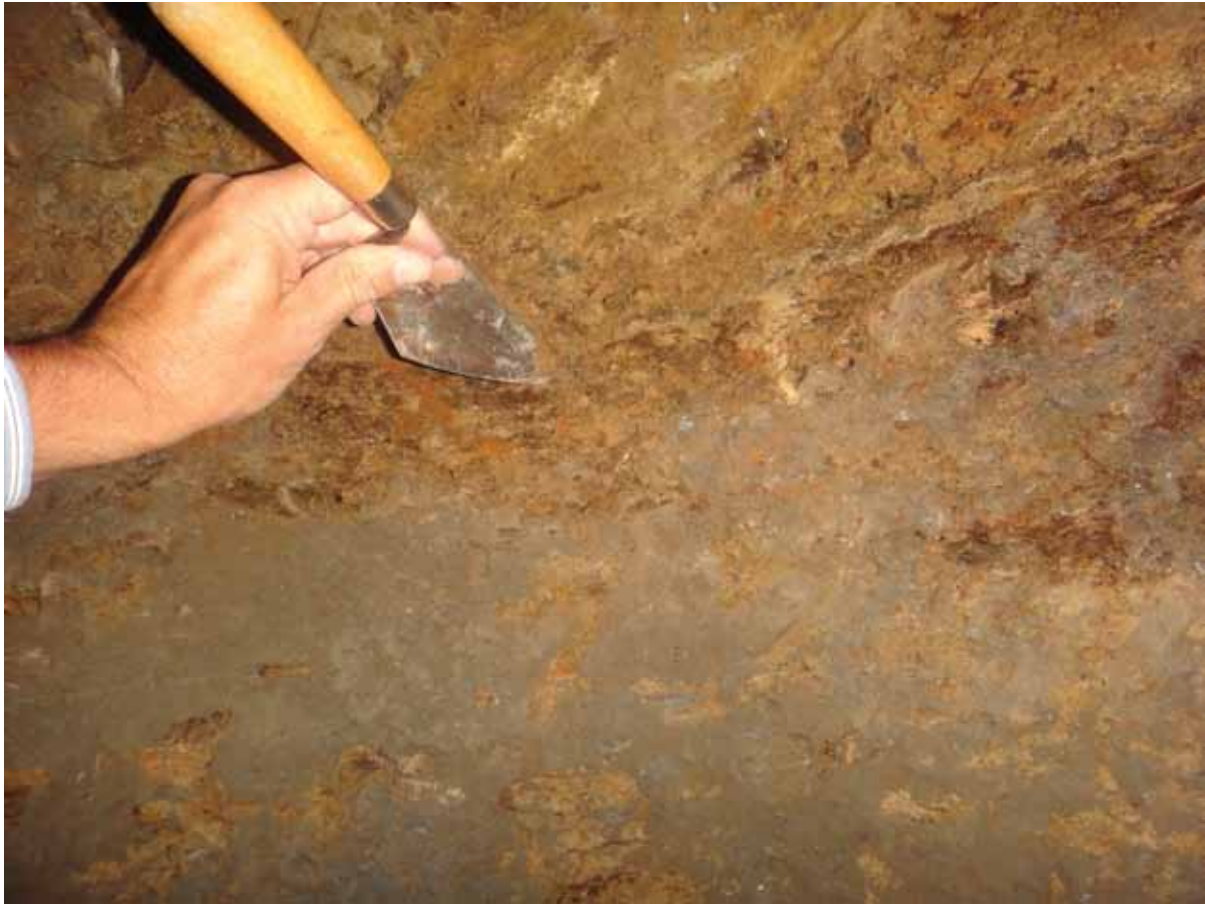
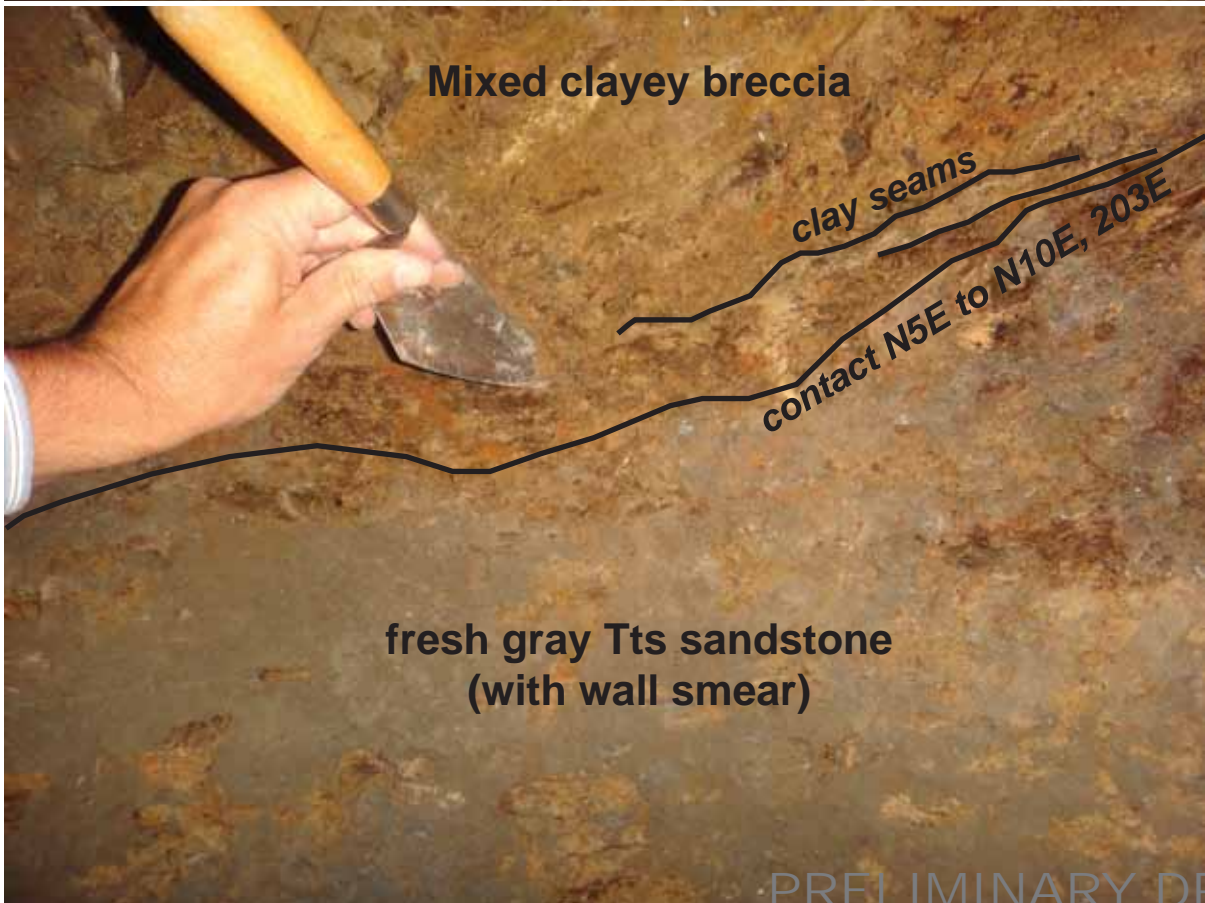
FIGURE  
2-11

PHOTOGRAPH OF EXPOSURE ON  
BORING LA2012-58A OF SOUTH WALL,  
DEPTH APPROXIMATELY 88 FEET

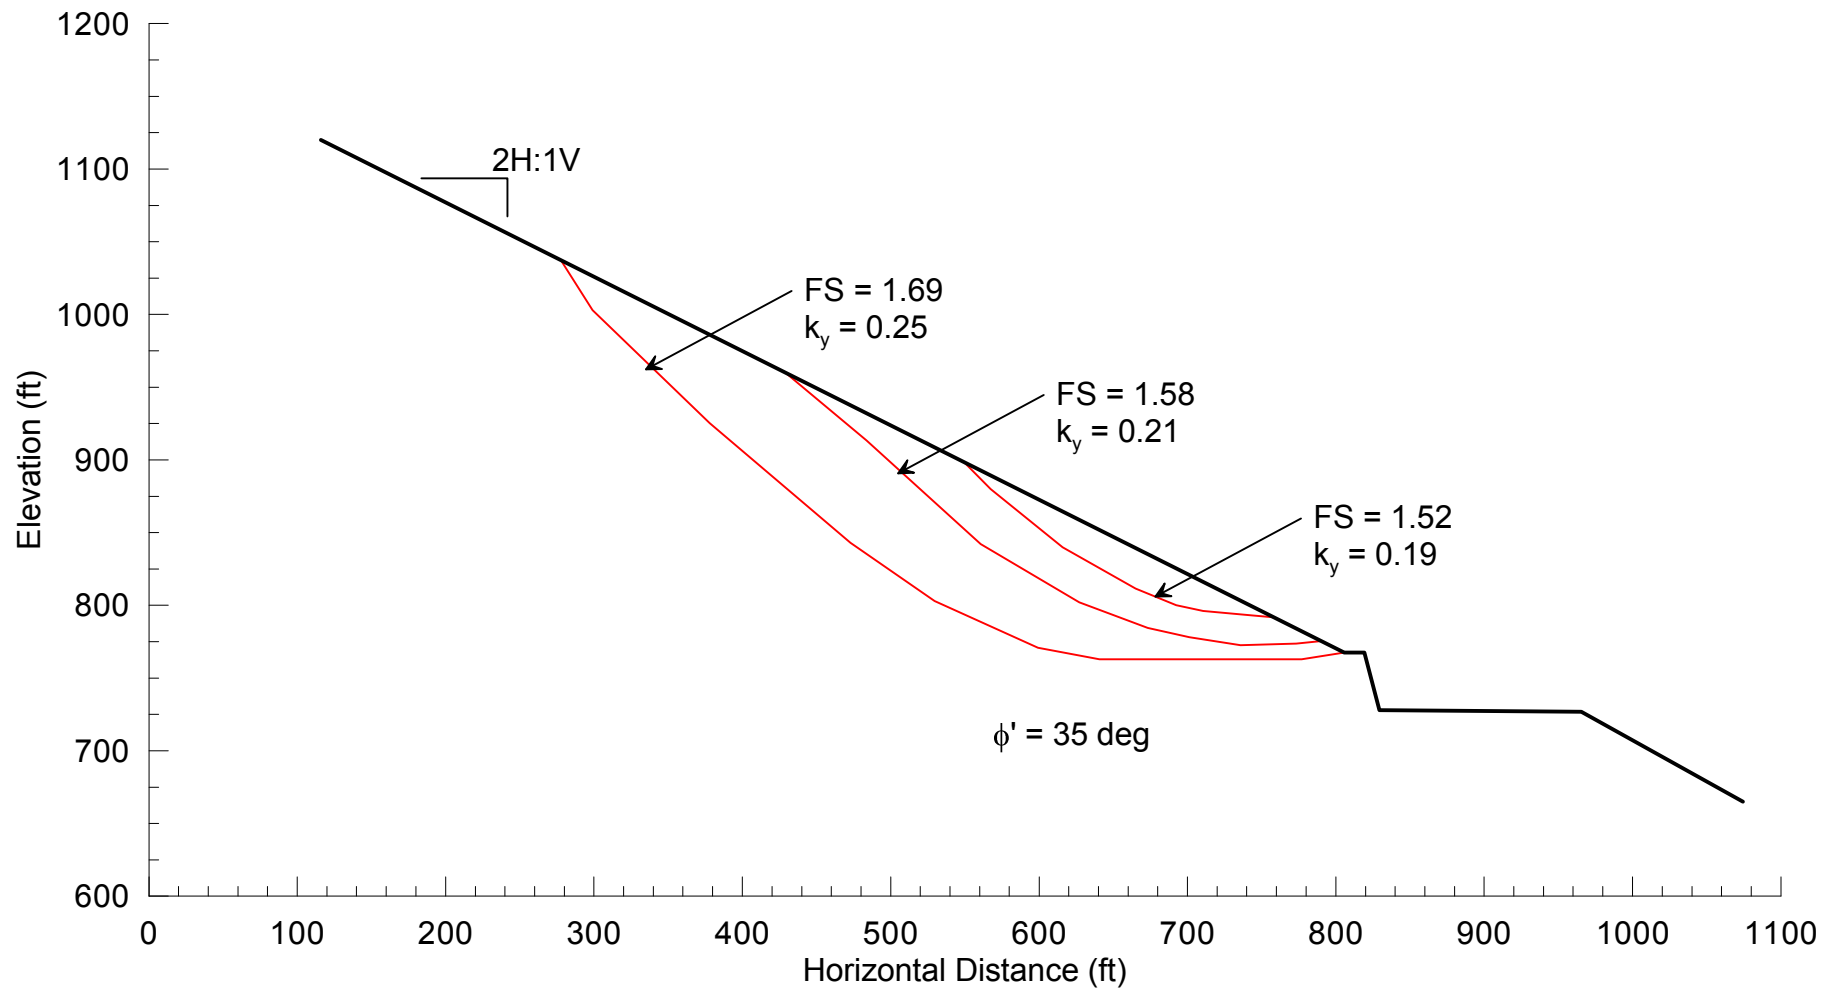
Project No. 26818183	SFPUC Calaveras Dam Replacement Project	Back-analysis of Section 3 for existing conditions	Figure 3-6
<b>URS</b>

- **Static Back-Analysis:** The back analysis of the static stability of Area A was calculated assuming FS=1.0. Locations of the cross-sections considered in the back analysis are shown on Figure 3-3. Section geometry and static back-analysis results are shown on Figures 3-4 to 3-6 and are summarized in Table 3-4. The stability back-analysis indicates friction angles ranging from 11.5° to 17.5° assuming no cohesion. This low friction angle is not considered representative for a slide in sandstone that apparently has not moved in a long time. Thus, the factors of safety of the analyzed sections are greater than assumed for the back analyses.

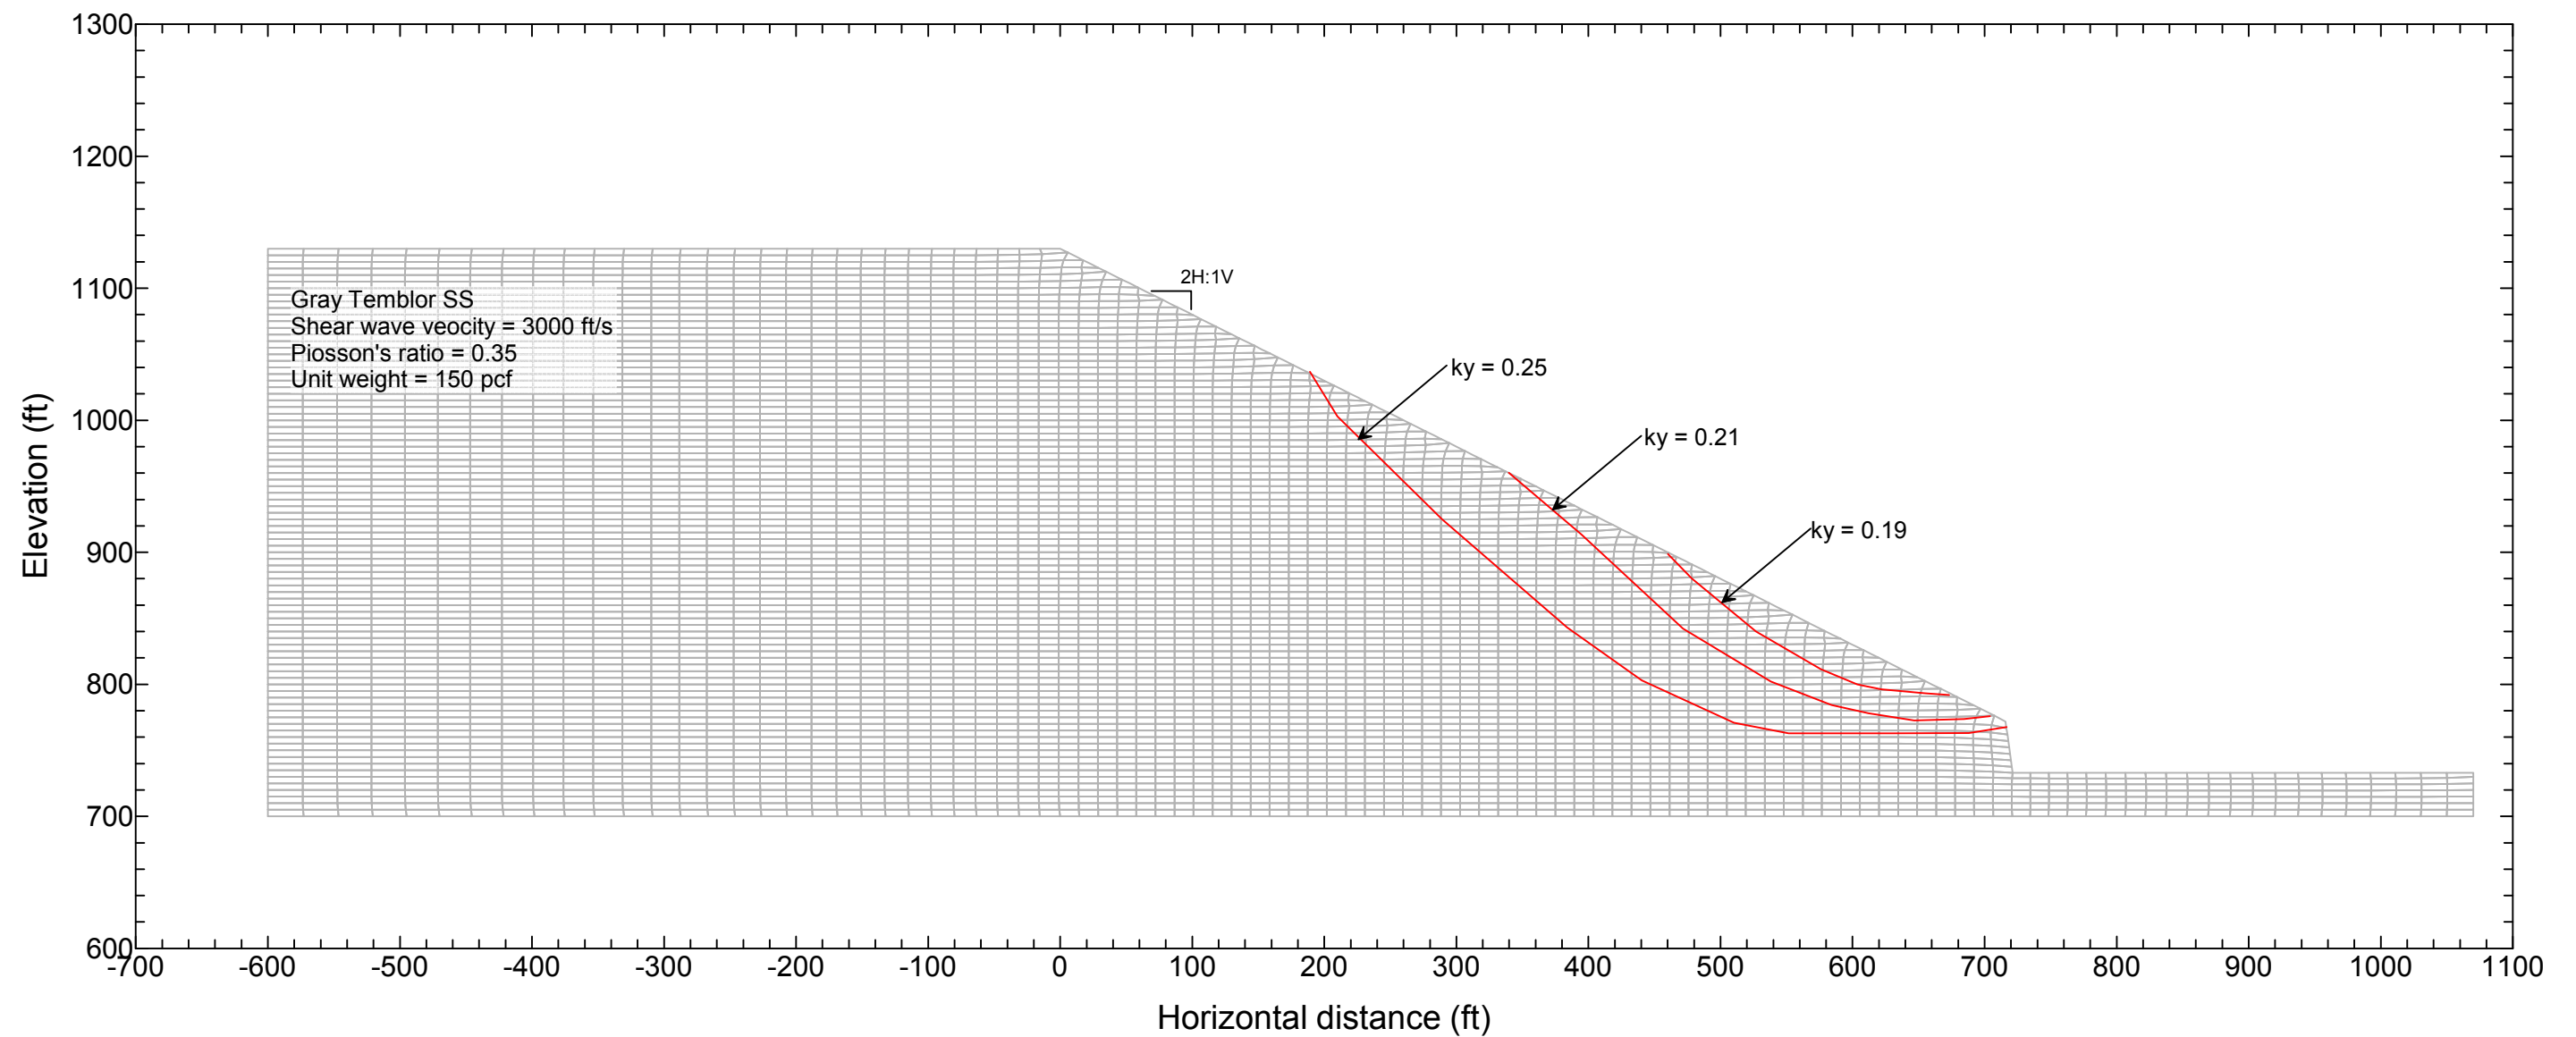
Project No. 26818183	SFPUC Calaveras Dam Replacement Project	Static and pseudo-static stability analysis of 2H:1V design slope	Figure 3-7
<b>URS</b>

In order to meet static stability criteria, reduce seismic deformations, and remove much of the Area A landslide mass from the northern half of the Observation Hill excavation, a design with an overall slope of 2H:1V (including benches) is proposed as shown on Drawings FD-1 and FD-1A. Analysis of a section using the 2H:1V slope is shown on Figure 3-7. Slides with depths of 30, 60, and 100 feet below the design surface, representing the Area A landslide mass at 75, 125, and 200 feet north of the dam axis, were analyzed. Only pre-defined slip surfaces were considered. This analysis shows that the flattened slope meets static stability criteria with a minimum factor of safety of 1.52. The yield acceleration coefficients (F.S. = 1.0) for these slip surfaces are also shown on Figure 3-7 and are summarized in Table 3-6.

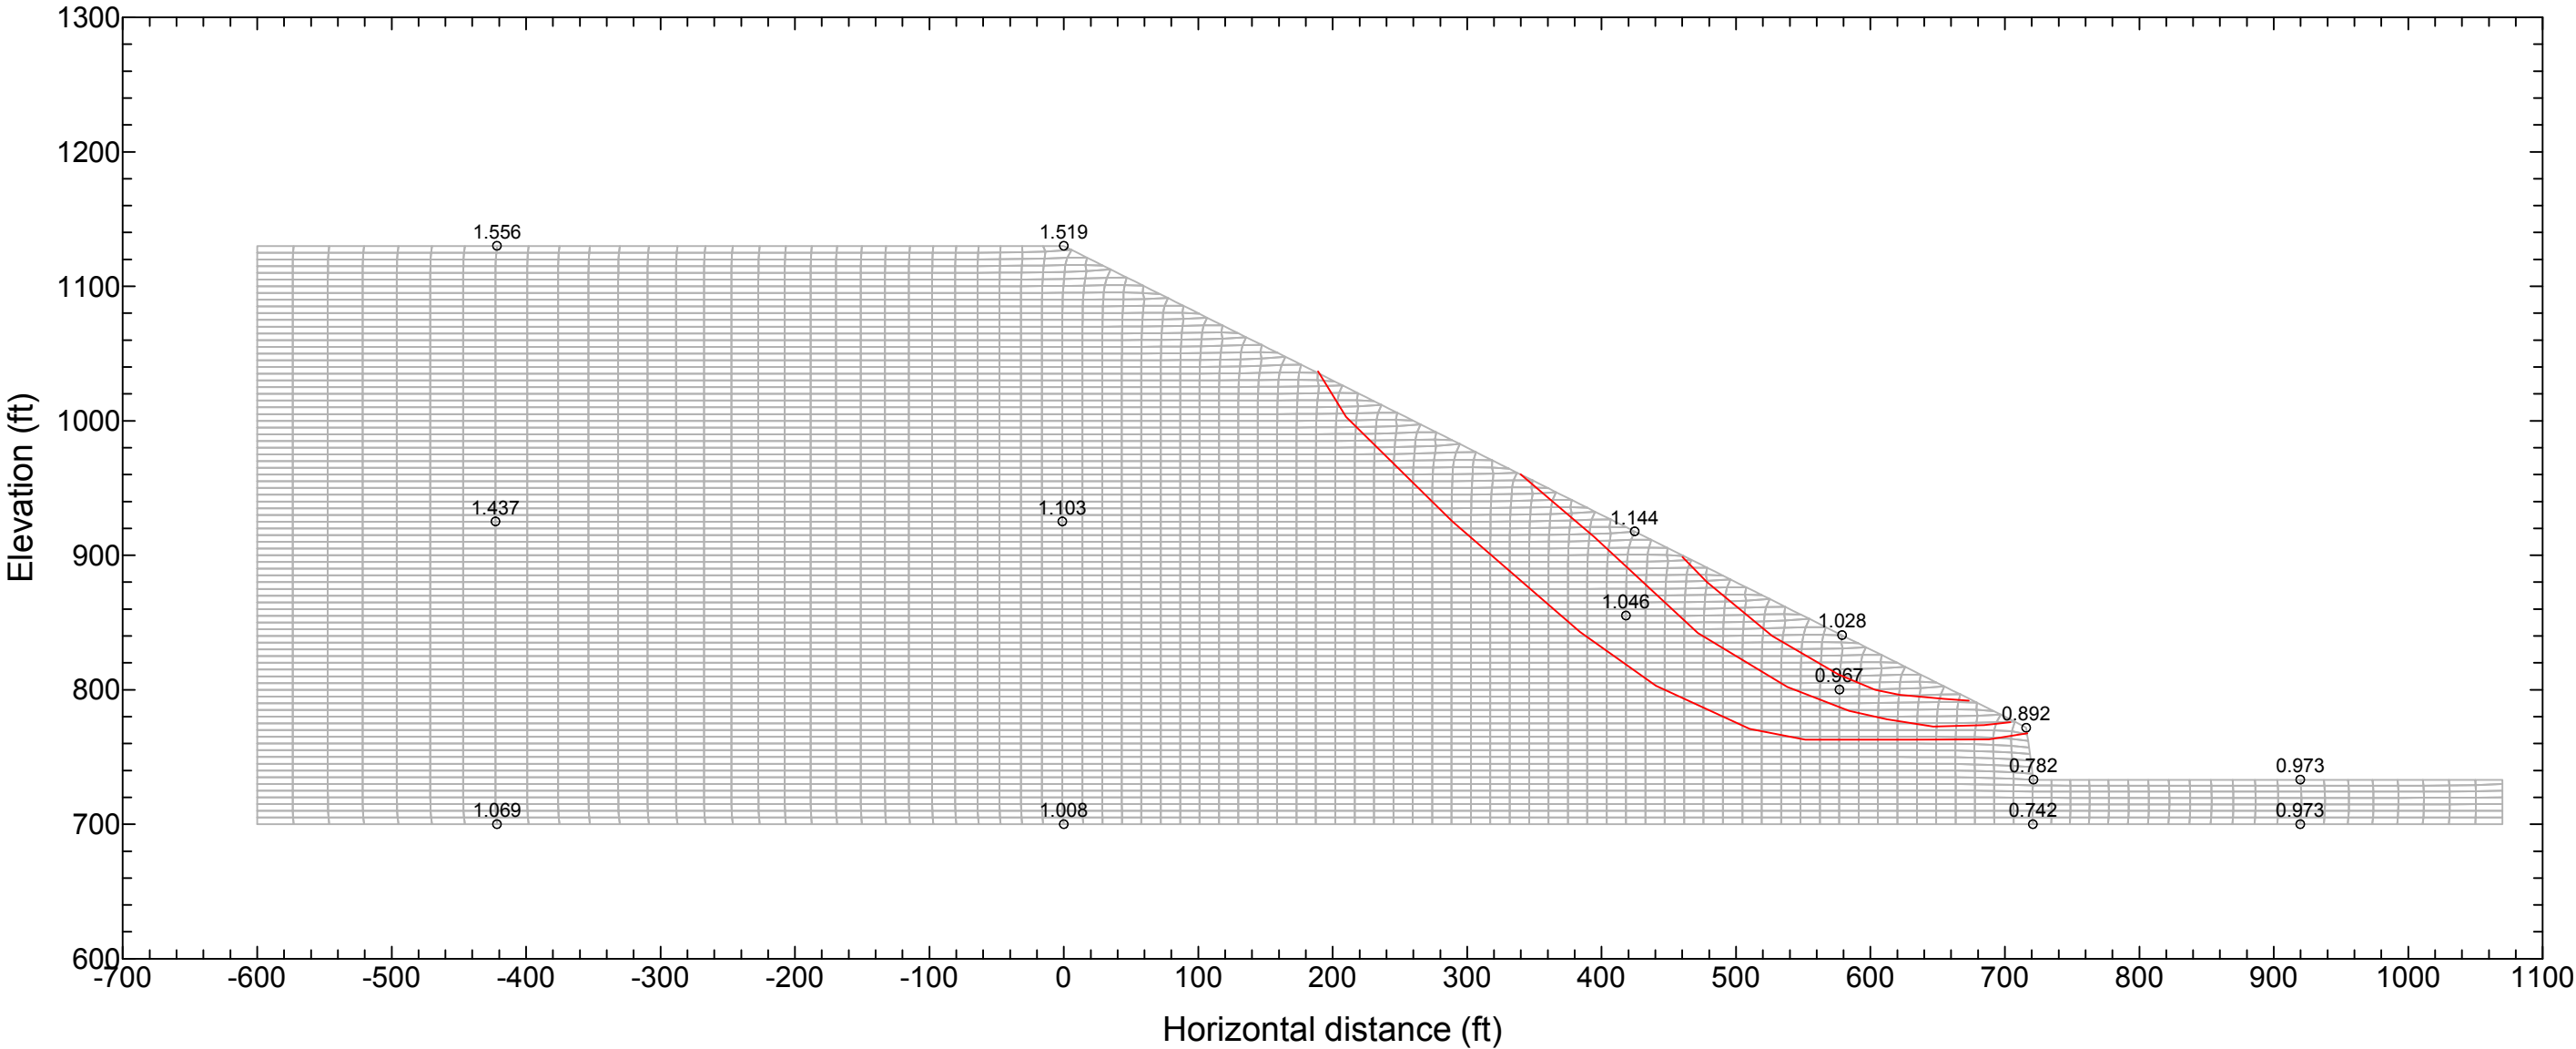
Project No. 26818183	SFPUC Calaveras Dam Replacement Project	2H:1V Spillway Cut Slope Model for QUAD4 Analysis	Figure  3-8
<b>URS</b>

The original 1.3H:1V slope was modeled using QUAD4 (Hudson, et al., 1994) as part of the original design (URS, 2007). This previous analysis was modified to reflect the flattened slope and include the three slip surfaces described above. All properties are identical to the previous analysis, except that the upper brown (weathered) Temblor sandstone is no longer present as it lies above the new 2H:1V excavation slope. The new model consists entirely of gray (unweathered) Temblor sandstone with  $V_s = 3000$  ft/s. The mesh geometry and slip surfaces used for input are shown in Figure 3-8.

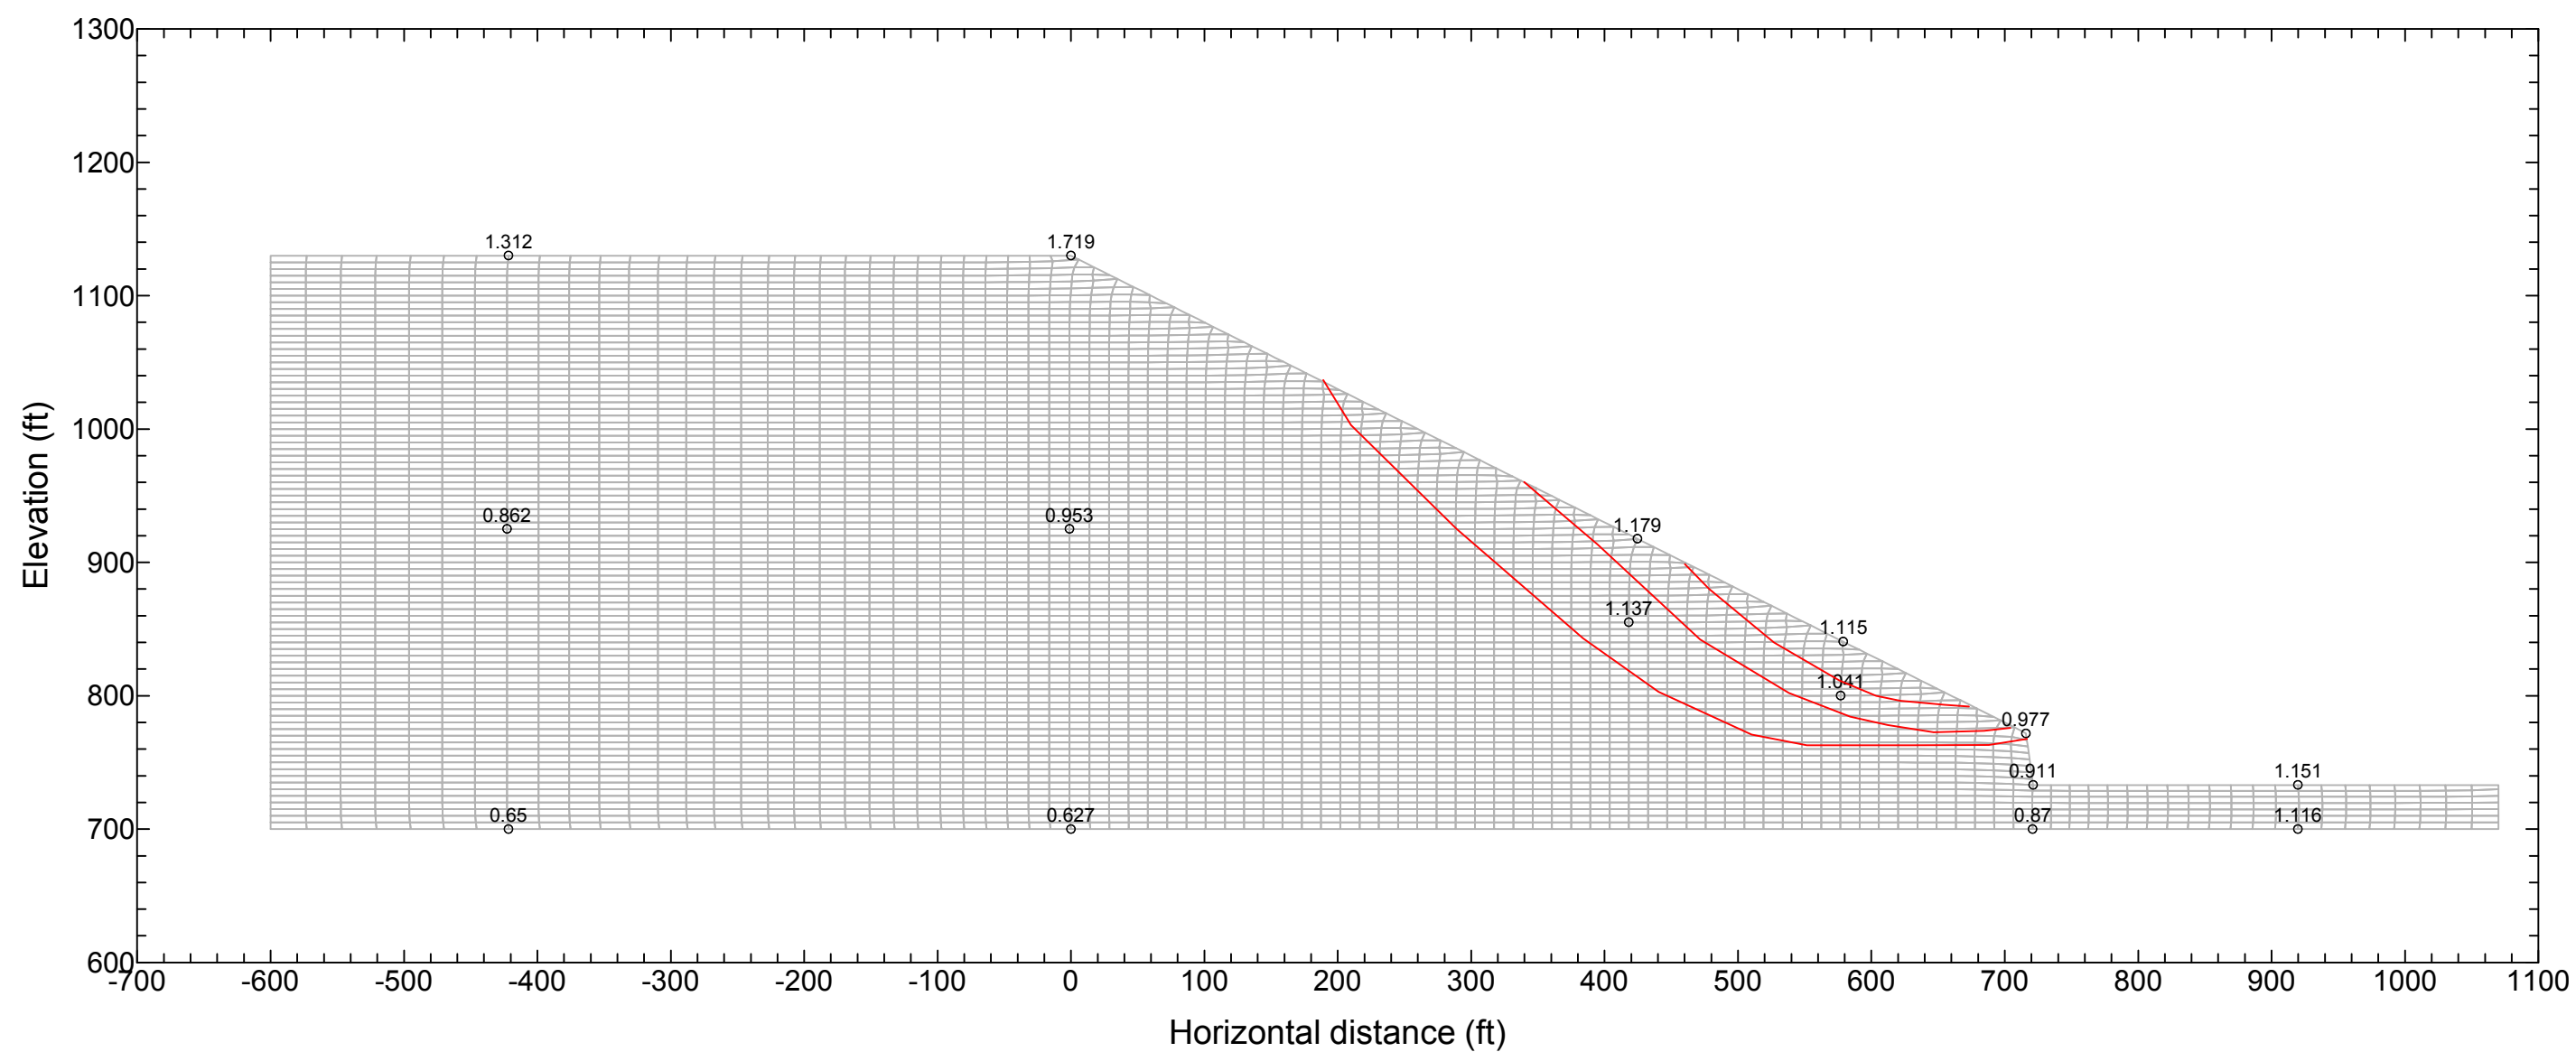
Project No. 26818183	SFPUC Calaveras Dam Replacement Project	PGA (g) 2H:1V Spillway Cut Slope Modified Tabas Motion	Figure  3-10
<b>URS</b>

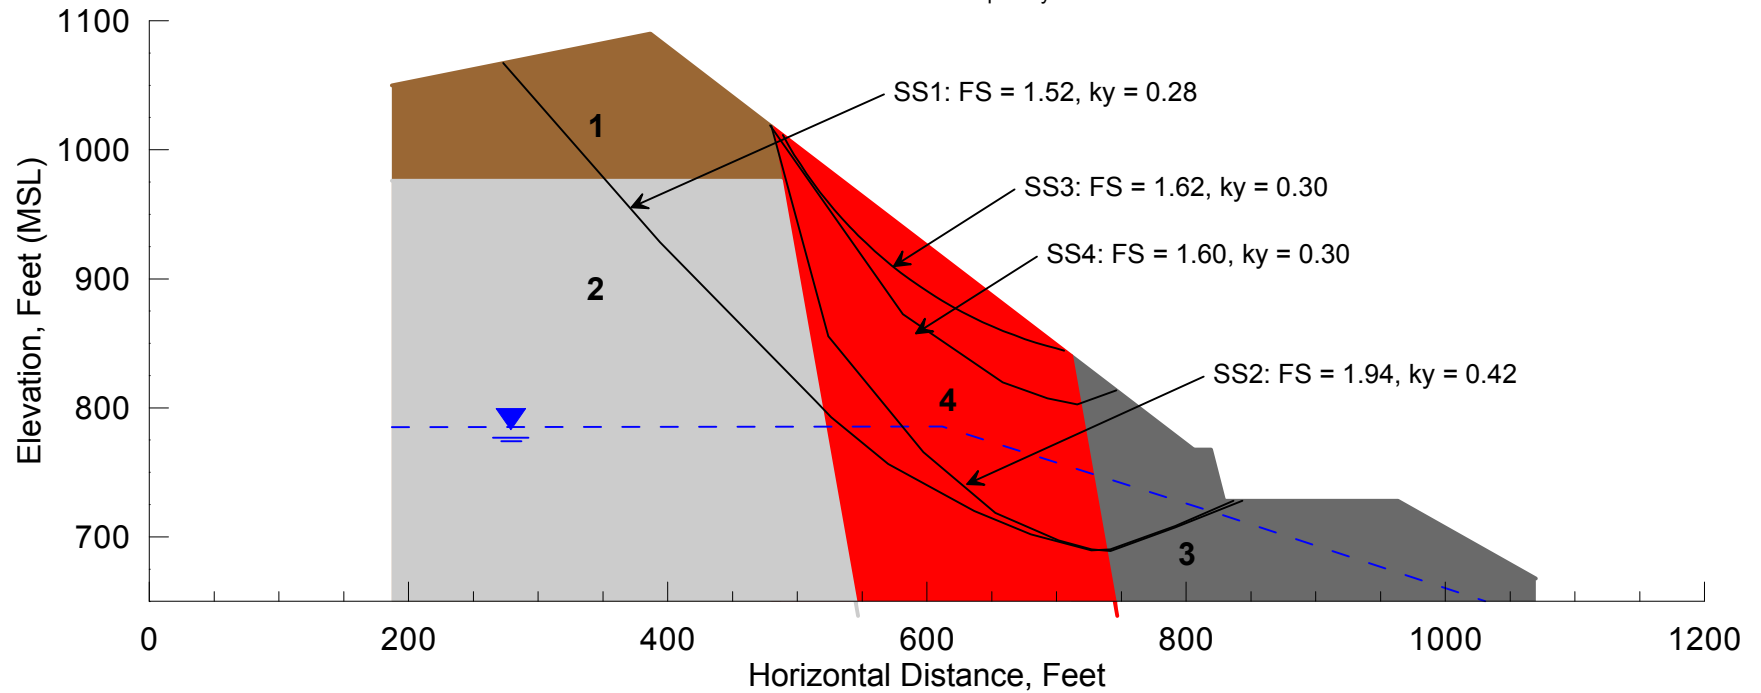
Project No. 26818183	SFPUC Calaveras Dam Replacement Project	Static and pseudo-static stability analysis of 1.3H:1V design slope	Figure  3-22

Number	Material	Cohesion (psf)	Friction Angle (Degree)	Bedding		
				Dip (deg)	Cohesion (psf)	Friction Angel (Deg)
1	HW SS	3850	29	45-55	650	35
2	SW SS	7200	50	45-55	650	35
3	SW SS	7200	50	20-30	650	35
4	SFZ	1000	35	-	-	-

HW SS - Highly Weathered Sandstone  
SW SS - Slightly Weathered Sandstone  
SFZ - Spillway Fault Zone

A seismic stability analysis of the 1.3H:1V slope south of the dam axis was conducted to check the stability of that slope considering the presence of the Spillway fault zone and the bedding upslope and downslope from the fault zone. The analysis section and properties used for the analysis are shown on Figure 3-22. Outside of the Spillway fault zone, the Temblor sandstone is modeled with bedding properties when slip surfaces are within 5 degrees of the bedding apparent dip. Rock mass properties are used for the Temblor sandstone when slip surfaces are greater than 5 degrees of the bedding apparent dip. Static stability analysis results shown on Figure 3-22 indicate that the design criteria for static stability are met.

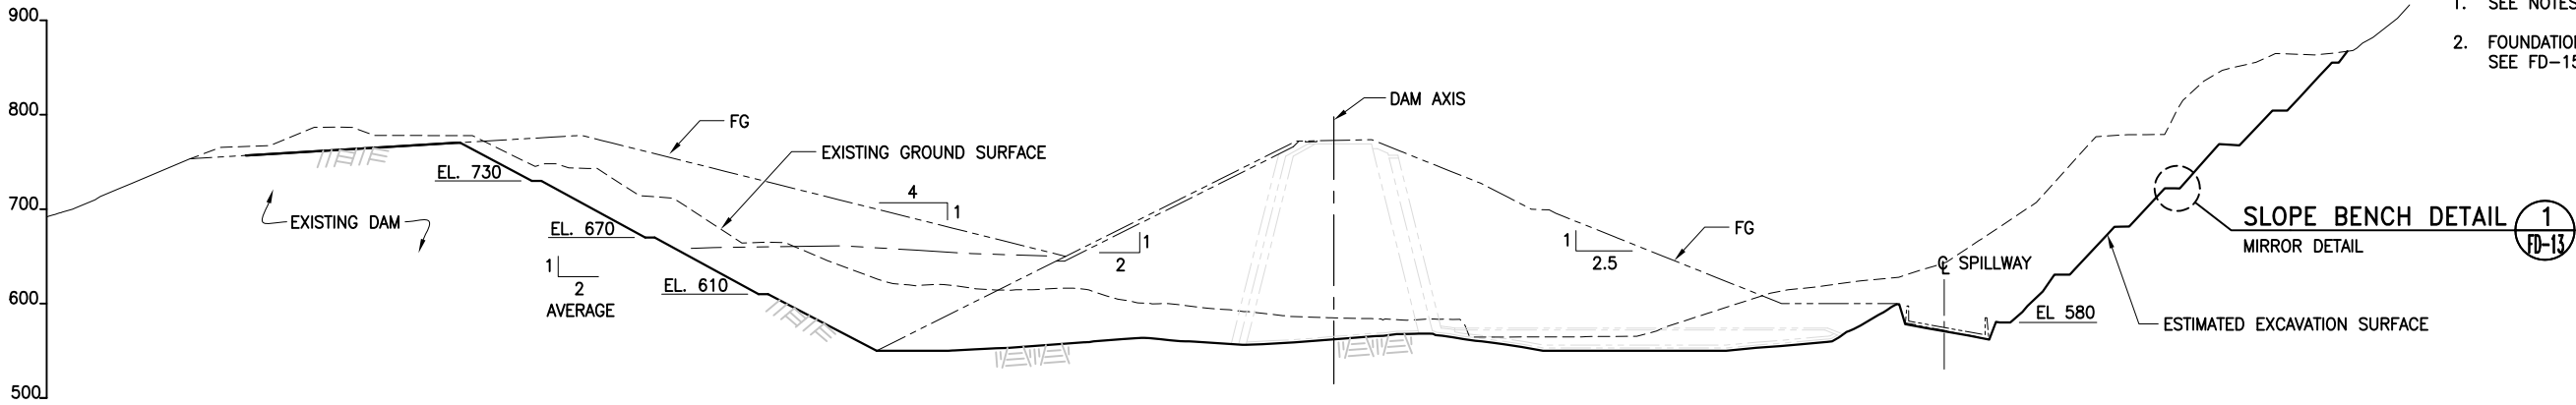
SECTION AT STATION 14+00  
SCALE 1"=100'

1. SEE NOTES ON FD-1
2. FOUNDATION GROUT CURTAIN NOT SHOWN. SEE FD-15 AND FD-16 FOR LOCATION.

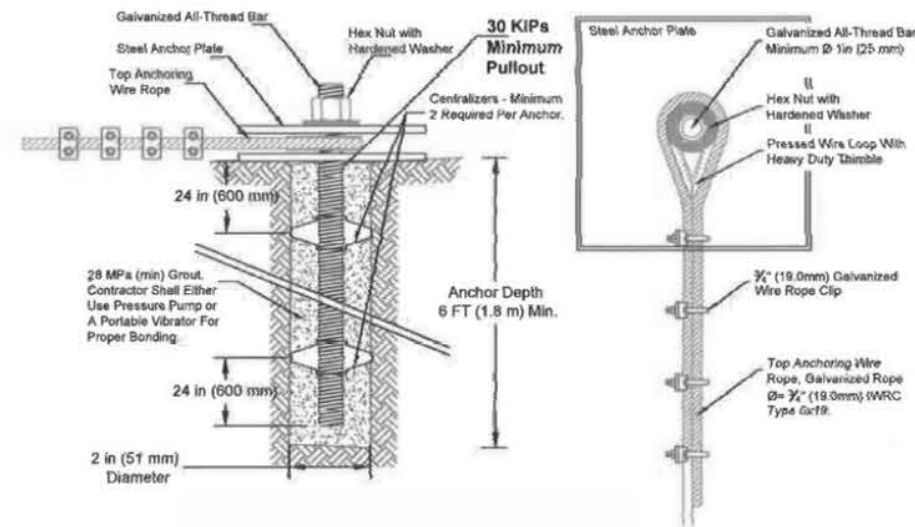
**ROCK NETTING ANCHOR DETAIL (TYP.)**  
NTS

BOTTOM OF SLOPE (BENCH) - 1 INCH THREADED BAR IN A 4 INCH HOLE, 6 FEET LONG EVERY 60 FEET (MAX).
5. CONNECTION BETWEEN ANCHOR AND NETTING SHALL BE AS PER NETTING MANUFACTURER RECOMMENDATIONS SHOWN AS DETAILS ON SHEETS FD-9.2 THROUGH FD-9.3.

6. ANCHORS SHALL HAVE A MINIMUM PULLOUT STRENGTH OF 30 kips (111 kN). ANCHORS SHALL BE PROOF TESTED AFTER THE GROUT HAS ACHIEVED SPECIFIED COMPRESSIVE STRENGTHS (TYPICALLY 72 HOURS CURE TIME). FIVE PERCENT OF THE TOTAL NUMBER OF ANCHORS SHALL BE PROOF TESTED BY THE CONTRACTOR IN THE PRESENCE OF CITY REPRESENTATIVE AT LOCATIONS OF THE CITY REPRESENTATIVES CHOOSING. IF AN ANCHOR FAILS, ALL OTHER ANCHORS GROUTED AT THE SAME TIME (SIMILAR GROUT MIX CONDITION) SHALL BE TESTED. IF ALL THE ANCHORS WERE GROUTED AT THE SAME TIME AND AN ANCHOR FAILS, THEN ALL THE ANCHORS SHALL BE TESTED. FAILED ANCHORS SHALL BE REPLACED BY THE CONTRACTOR AT NO ADDITIONAL COST TO THE CITY.

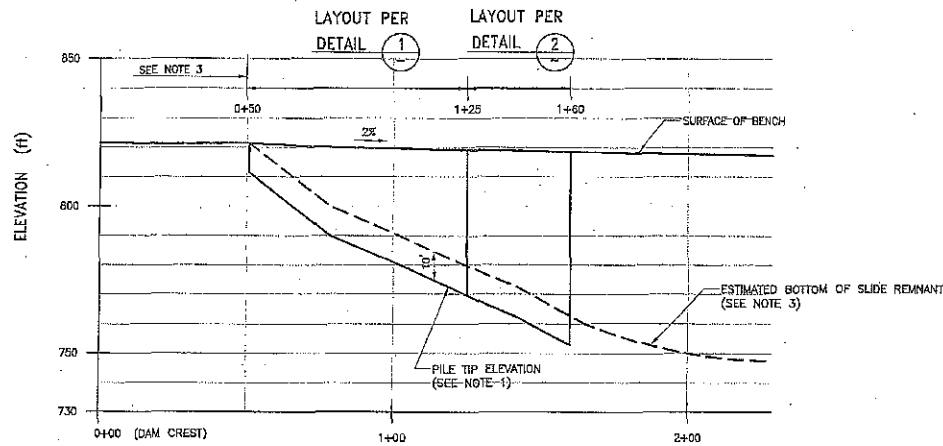
SLOPE REINFORCEMENT PROFILE  
SCALE 1"=20'

1. TIP OF PIERS SHALL PENETRATE AT LEAST 10 FEET INTO ROCK BENEATH BOTTOM OF SLIDE REMNANT.
2. CONCRETE TO BE 4000A.
3. STARTING LOCATION TO BE CONFIRMED BY CITY REPRESENTATIVE.

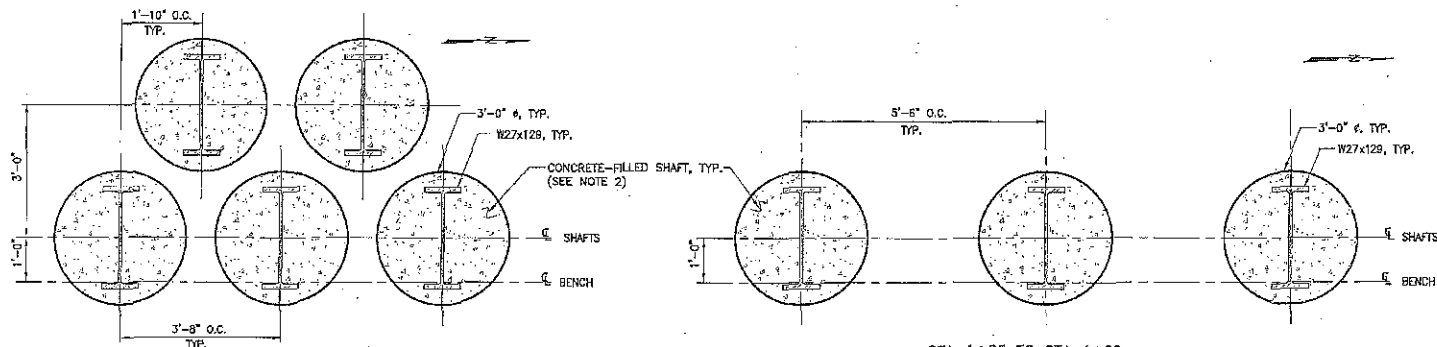
DETAIL  
SCALE 3/4"=1'-0"

STA 0+50' TO STA 1+25

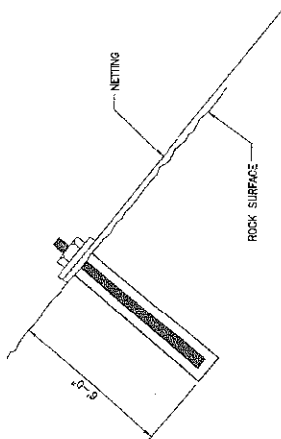
ROCK NETTING ANCHOR DETAIL (TYP.)

1. ROCK NETTING SHALL BE MACADAMEROCK MESH 4000 - OR SIMILAR.
2. ROCK NETTING SHALL BE GALVANIZED.
3. ROCK NETTING SHALL BE PLACED EXTENDING 10 FEET BEYOND THE LIMIT OF THE EXCAVATION.
4. ANCHORS TO SUPPORT THE ROCK NETTING SHALL BE PLACED AS FOLLOWS:  
 TOP OF SLOPE (BENCH) - 1 INCH REBAR IN A 4 INCH HOLE, 6 FEET LONG EVERY 30 FEET.  
 MID SLOPE - 1 INCH REBAR IN A 4 INCH HOLE, 6 FEET LONG EVERY 30 FEET.  
 BOTTOM OF SLOPE (BENCH) - 1 INCH REBAR IN A 4 INCH HOLE, 9 FEET LONG EVERY 30 FEET.
5. CONNECTION BETWEEN ANCHOR AND NETTING SHALL BE AS PER NETTING MANUFACTURER RECOMMENDATIONS.

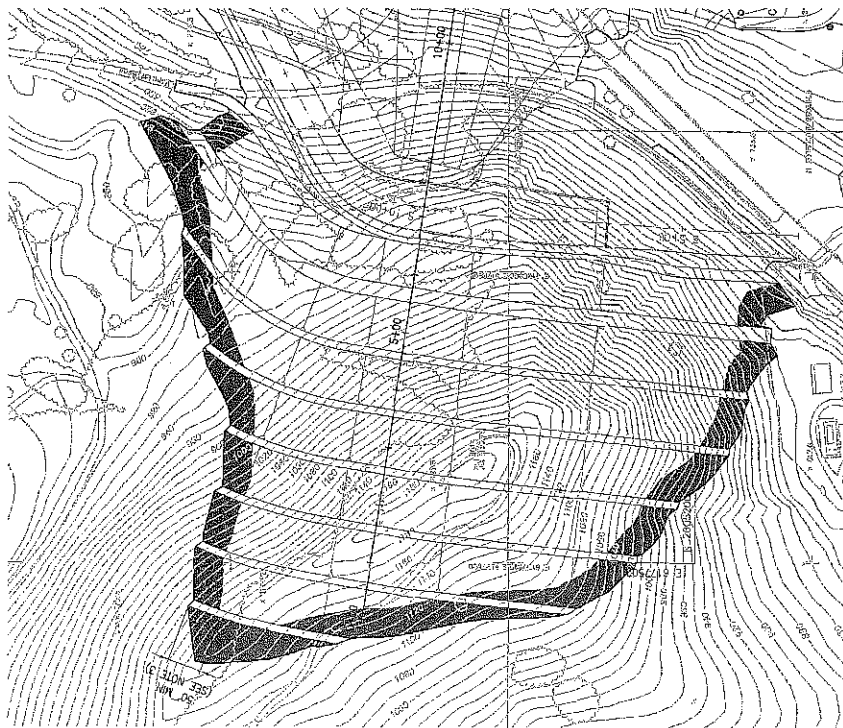
PLAN  
SCALE 1"=100'

ESTIMATED AREAS REQUIRING  
ROCK SLOPE NETTING
