**PUBLIC UTILITIES
REVENUE BOND OVERSIGHT COMMITTEE
CITY AND COUNTY OF SAN FRANCISCO
AGENDA**

4. Draft Report of Contract CS-363, "Construction Management Services – RBOC Evaluation of Lessons Water System Improvement Program." *(Attachment)*
(Discussion and Action)

EXECUTIVE SUMMARY	4
ENGAGEMENT SCOPE OF WORK.....	8
OVERVIEW OF WSIP	10
Project Development and Controls	15
WSIP Status.....	20
WSIP PROJECT SITE VISITS.....	22
Calaveras Dam Replacement (CUW37401)	22
New Irvington Tunnel (CUW35901)	27
Bay Division Pipeline Reliability Upgrade Tunnel (CUW36801)	31
Harry Tracy Water Treatment Plant (CUW36701).....	35
Crystal Springs/San Andreas (CSSA) Transmission System Upgrade (CUW37101).....	40
Lincoln Pipeline (CUW-31201)	44
CHANGE MANAGEMENT	44
PROJECT DELIVERY COSTS	48
CONSTRUCTION BIDDING	57
DISPUTED COSTS	60
DESIGN.....	62
QUALITY ASSURANCE/QUALITY CONTROL	65
RISK MANAGEMENT	67
OVERVIEW OF SSIP.....	69

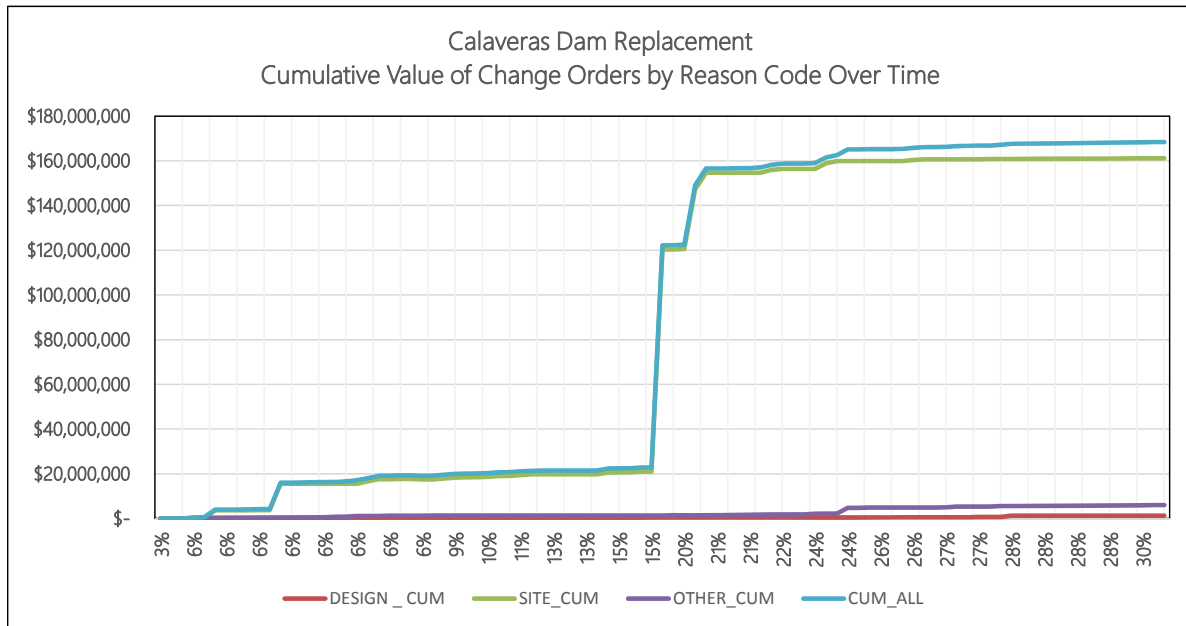
Figure 1-Calaveras Dam Replacement Change Order Approval Over Time By Reason Code

In addition to the information provided in Table 7 pertaining to summary values of approved change orders by reason code, RWBC created a time-based plot of change orders by reason code where the approved change orders are plotted against the percent time (construction duration) when the applicable change was approved. In order to simplify the number of curves included in Figure 1⁹, we summarized change order into three broad categories: design related changes (errors, omissions), differing site conditions, and other (including owner requested changes, risk management changes and any other modification that was not related to design or differing site conditions). As reflected in the data analyzed the largest change was identified early in the project and the project team was able to negotiate a very complex modification without having a resulting claim. This is significant given the general contractor is a first time joint venture (partners had not worked under this arrangement previously) which added to the risk profile of the project. Detailed information on approved change orders is provided as EXHIBIT 1.

⁹ This graph provides the cumulative value of approved change orders (defined as fully executed change orders) grouped into three major reason codes: design, differing site conditions, and other. Design (reflected as DESIGN_CUM in Figure 1) includes architect/engineer errors and omissions, site conditions (reflected as SITE_CUM in Figure 1) include all modifications resulting from encountering differing site conditions, and other (reflected as OTHER_CUM in Figure 1) incorporates all other reason codes including owner requested changes, risk mitigation, and alternative means and methods, for example. A fourth plot line is included which is the cumulative value over project time (reflected as CUM_ALL in Figure 1) for all approved change orders.
