**PUBLIC UTILITIES  
REVENUE BOND OVERSIGHT COMMITTEE  
CITY AND COUNTY OF SAN FRANCISCO  
MINUTES**

**February 9, 2015 - 9:00 AM**

### Calaveras Dam Replacement (CUW37401)

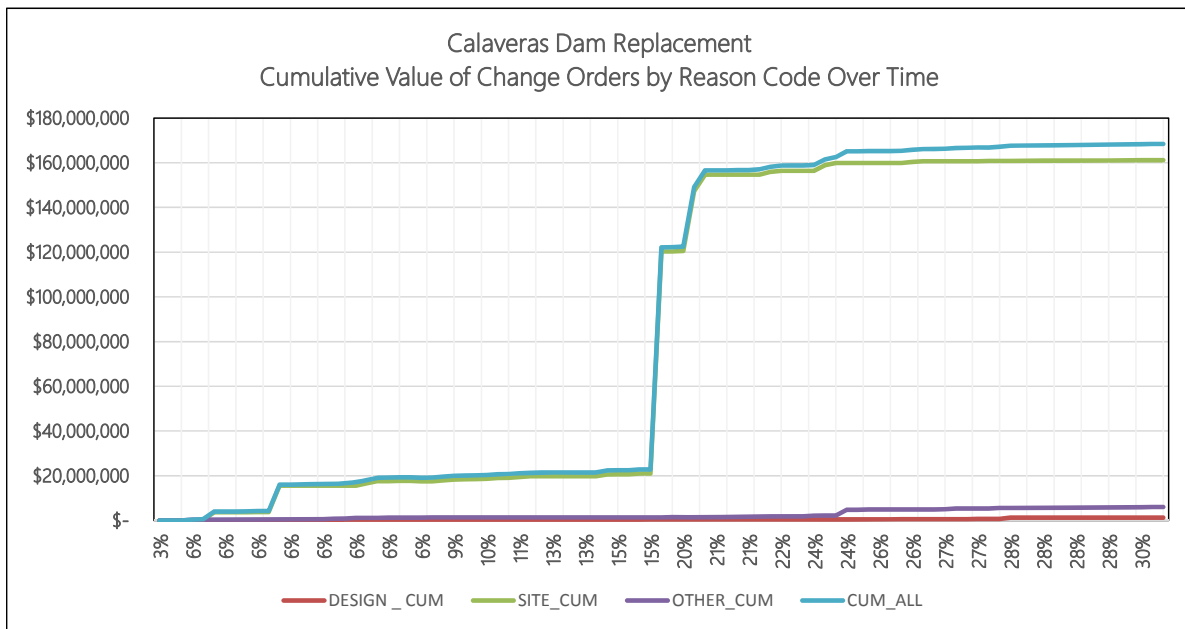
Figure 3-Calaveras Dam Replacement Change Order Approval Over Time By Reason Code

negotiate a very complex modification without having a resulting claim. This is significant given the general contractor is a first time joint venture (partners had not worked under this arrangement previously) which added to the risk profile of the project. Detailed information on approved change orders is provided as EXHIBIT 1.

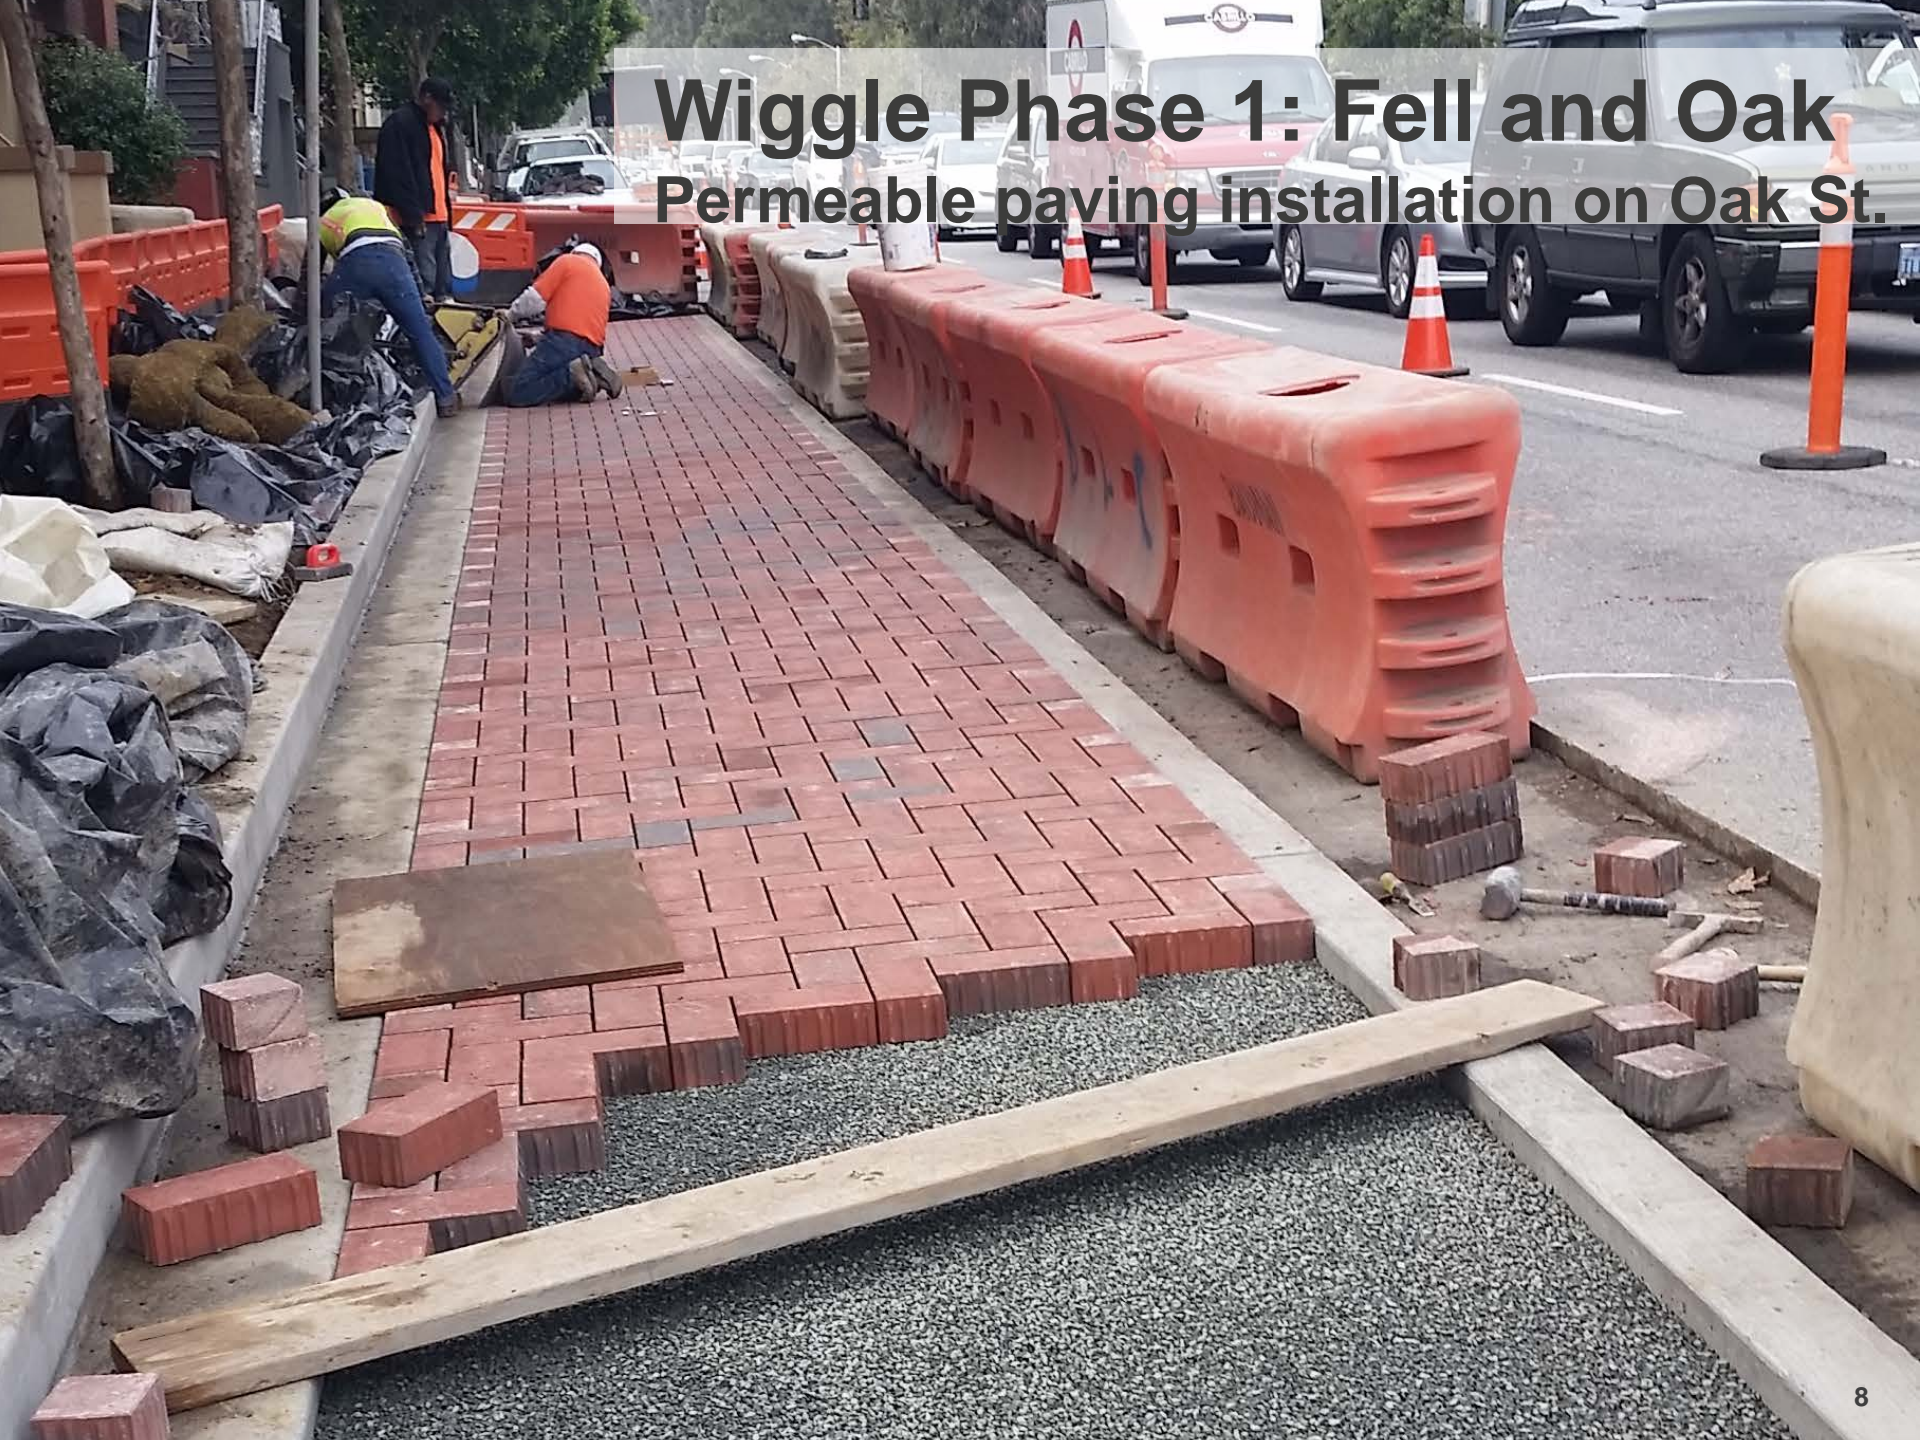
# Wiggle Phase 1: Fell and Oak

## Permeable paving installation on Oak St.
