**PUBLIC UTILITIES
REVENUE BOND OVERSIGHT COMMITTEE
CITY AND COUNTY OF SAN FRANCISCO
AGENDA**

6. Draft Report, Contract CS-363, "Construction Management Services – RBOC Evaluation of Lessons Learned, Water System Improvement Program." *(Attachment) (Discussion and Action)*

7. San Francisco Public Utilities Commission (SFPUC) Staff Report: Water System Improvement Program (WSIP) Update *(Attachment) (Discussion)*

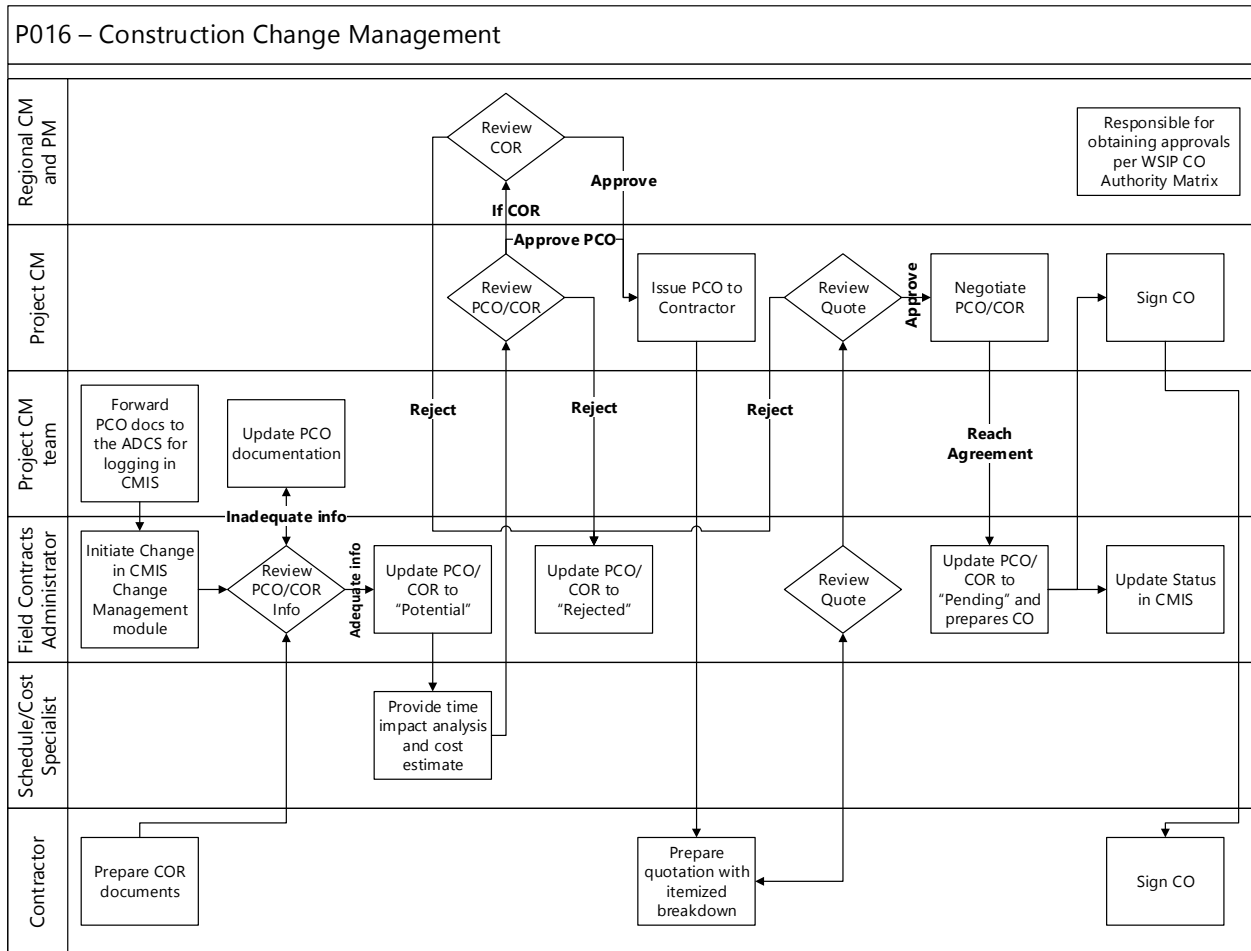
Figure 8 - Construction change management process flowchart

The WSIP program management team followed a prescribed methodology for identification, review, and approval of construction change orders. Our site visits show that in general all visited projects followed the same methodology for administering the construction change order process. There may be stylistic differences which are reflective of each staff's own approach to achieving prescribed activities within a process, yet this is to be expected. Figure 8, below, provides a detailed process flow map developed by RWBC to highlight the steps involved in the preparation, review, and approval of construction change orders.
