PUBLIC UTILITIES REVENUE BOND OVERSIGHT COMMITTEE CITY AND COUNTY OF SAN FRANCISCO AGENDA

August 19, 2015 - 11:00 AM

6. San Francisco Public Utilities Commission (SFPUC) Staff Report: Water System Improvement Program (WSIP) Update (*Discussion*)

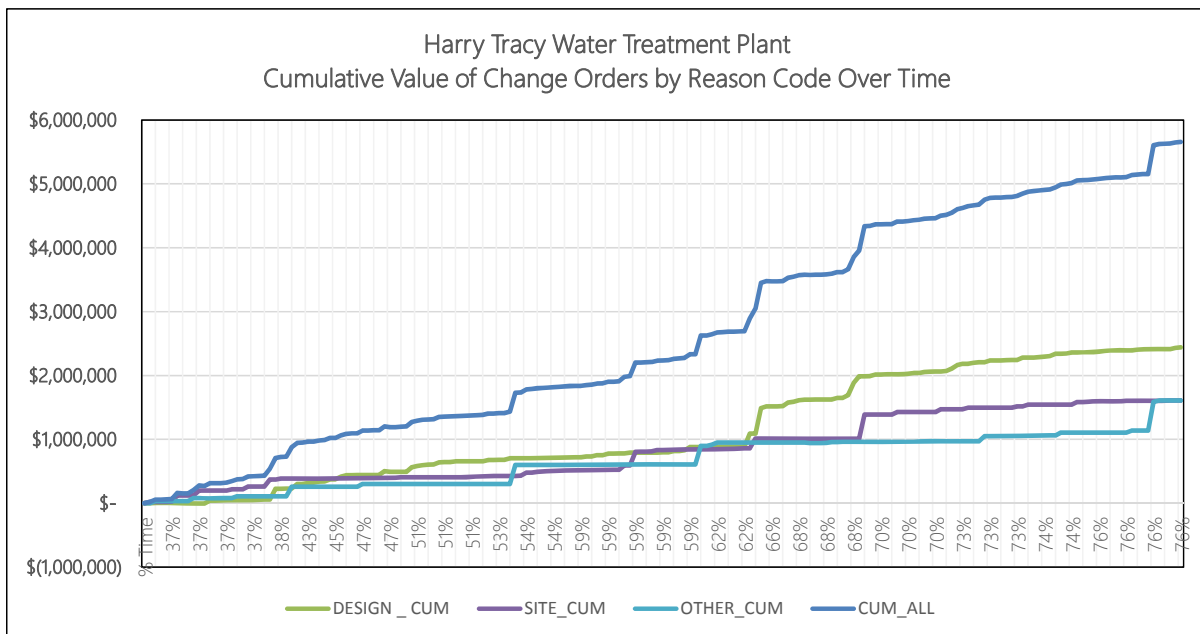
Figure 5 - Harry Tracy Water Treatment Plan Change Order Approval Over Time By Reason Code

Figure 5, below, shows that changes occurred throughout this project under a high frequency lower dollar volume than the other 5 projects evaluated. The project team has had to deal with a high volume of requests for change from the general contractor which in many instances did not have merit, yet required program management resources to address. Aside from the time extension from the 2005 Baseline, this issue was a driver in the 79% increase to construction management costs as well as the 21.9% management costs (ref. Table 14 for details). Detailed approved change order information is provided as EXHIBIT 4.

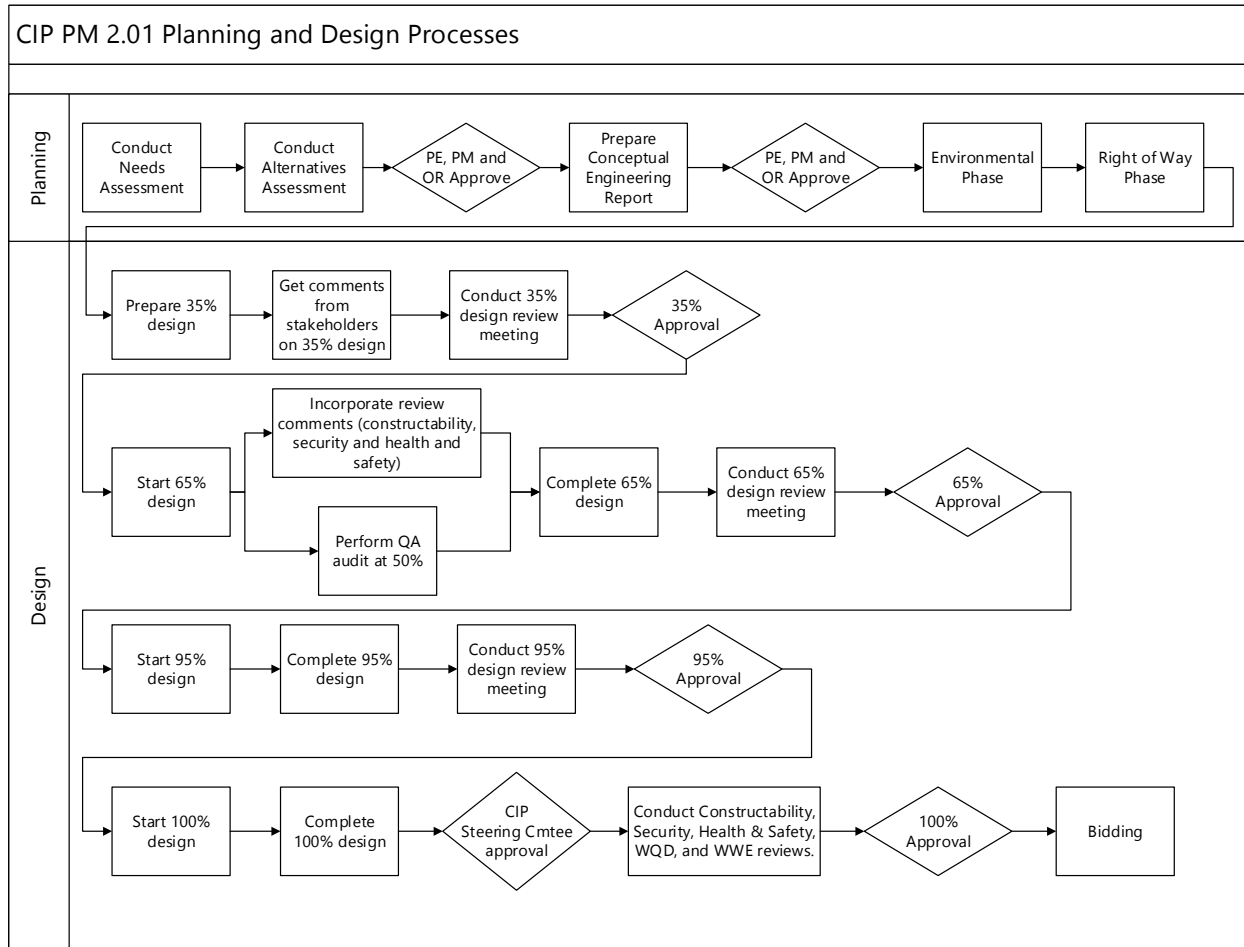
Figure 11 - Planning and design processes flow chart

Based upon review of applicable documentation and interviews, we found that the project management team followed prescribed policies and procedures associated with the design process. RWBC also prepared a detailed process flow chart of the design (and planning) process to highlight the steps involved in developing design documents, in Figure 11, below.
